YOUR ONESURVEY
HOME REPORT

8 Logie Drive
Crimond
Fraserburgh
AB43 8QW

SINGLE SURVEY

Single Survey

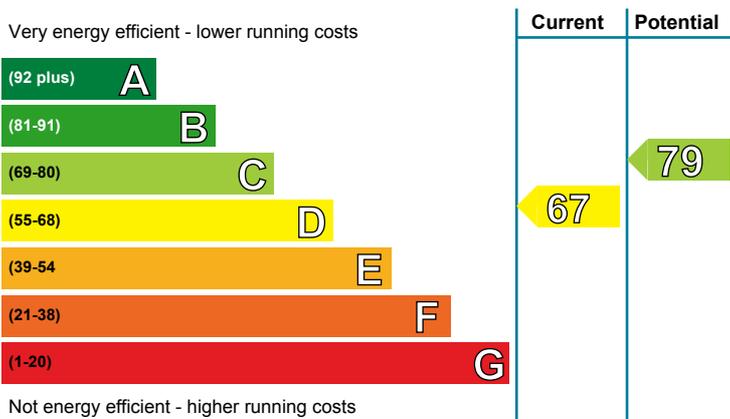
Energy Efficiency Rating

This graph shows the current efficiency of your home, taking into account both energy efficiency and fuel costs. The higher this rating, the lower your fuel bills are likely to be.

Your current rating is **band D (67)**. The average rating for EPCs in Scotland is **band D (61)**.

The potential rating shows the effect of undertaking all of the improvement measures listed within your recommendations report.

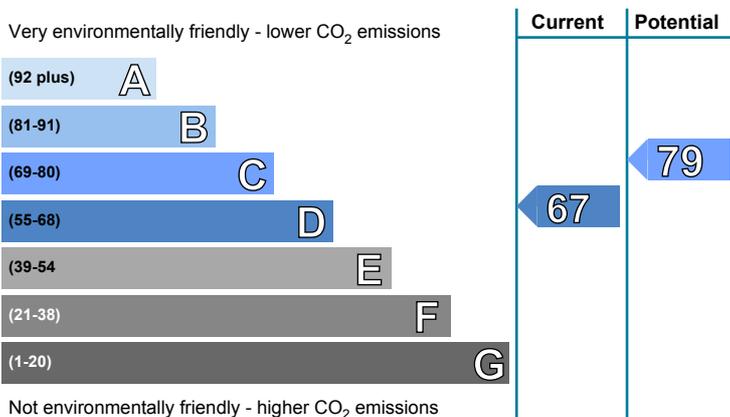
Environmental Impact (CO₂) Rating

This graph shows the effect of your home on the environment in terms of carbon dioxide (CO₂) emissions. The higher the rating, the less impact it has on the environment.
