Home Report

Scottish Single Survey

Single Survey

Property address	27 Morar Place Renfrew PA4 9DP
Customer	Mary Ann Ross
Customer address	27 Morar Place Renfrew PA4 9DP
Prepared by	Shepherd Chartered Surveyors
Date of inspection	03/07/2026

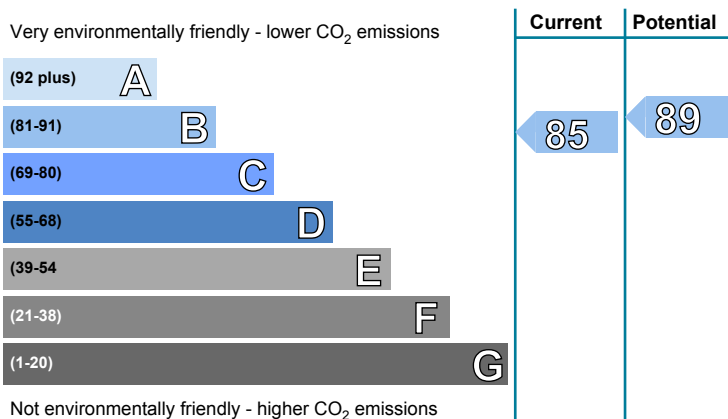
Environmental Impact (CO₂) Rating

This graph shows the effect of your home on the environment in terms of carbon dioxide (CO₂) emissions. The higher the rating, the less impact it has on the environment.
