Home Report

Single Survey

Property Address	14 Keiller Avenue, Dundee, DD4 7FJ
Reference	DD202604-56631
Customer Name	Gordon Pirie
Date of Inspection	15th April 2026
Surveyor's name, qualifications and office	Jack Chinery AssocRICS DM Hall LLP Chartered Surveyors Shed 26, Unit 34, City Quay Camperdown Street Dundee DD1 3JA Tel: 01382 873100 email: dundeeresidential@dmhall.co.uk
Prepared By	DM Hall LLP

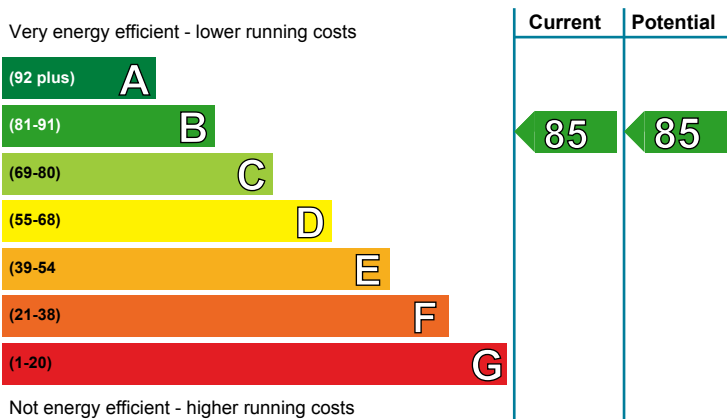
Energy Efficiency Rating

This graph shows the current efficiency of your home, taking into account both energy efficiency and fuel costs. The higher this rating, the lower your fuel bills are likely to be.

Your current rating is **band B (85)**. The average rating for EPCs in Scotland is **band D (61)**.

The potential rating shows the effect of undertaking all of the improvement measures listed within your recommendations report.

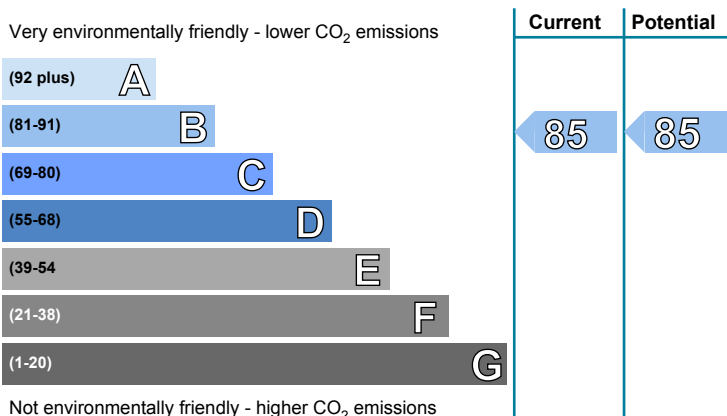
Environmental Impact (CO₂) Rating

This graph shows the effect of your home on the environment in terms of carbon dioxide (CO₂) emissions. The higher the rating, the less impact it has on the environment.
