Home Report

Scottish Single Survey

Single Survey

Property address	8 Devon Road Alloa FK10 1PX
-------------------------	-----------------------------------

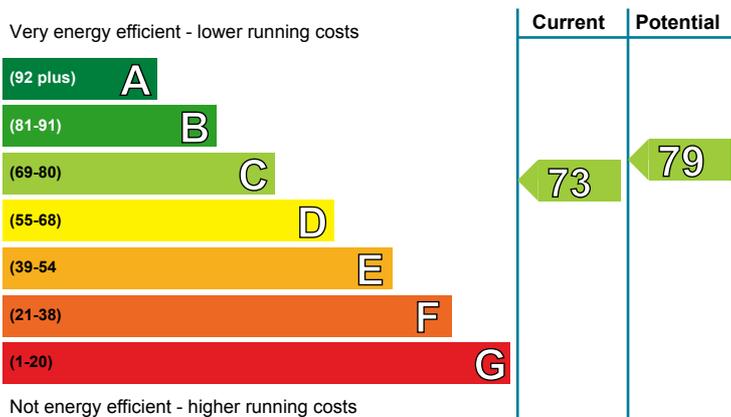
Energy Efficiency Rating

This graph shows the current efficiency of your home, taking into account both energy efficiency and fuel costs. The higher this rating, the lower your fuel bills are likely to be.

Your current rating is **band C (73)**. The average rating for EPCs in Scotland is **band D (61)**.

The potential rating shows the effect of undertaking all of the improvement measures listed within your recommendations report.

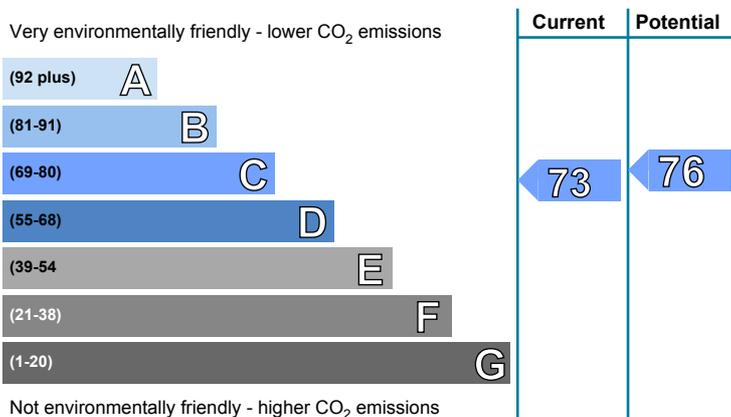
Environmental Impact (CO₂) Rating

This graph shows the effect of your home on the environment in terms of carbon dioxide (CO₂) emissions. The higher the rating, the less impact it has on the environment.
