# Home Report

2/1 19 Ardbeg Street  
Govanhill Glasgow G42 7RD

# Single Survey

<b>Property Address</b>	2/1 19 Ardbeg Street Govanhill Glasgow G42 7RD
<b>Customer</b>	Anderson Property Investmenst Ltd
<b>Prepared by</b>	Graham + Sibbald Property Consultants Limited
<b>Date of Inspection</b>	08/06/2026

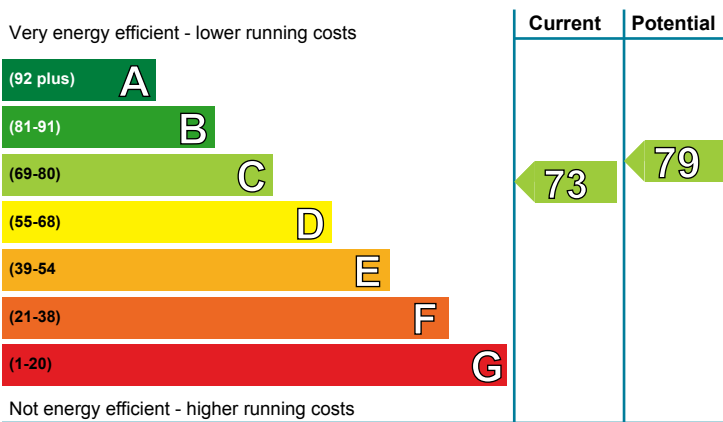
## Energy Efficiency Rating

This graph shows the current efficiency of your home, taking into account both energy efficiency and fuel costs. The higher this rating, the lower your fuel bills are likely to be.

Your current rating is **band C (73)**. The average rating for EPCs in Scotland is **band D (61)**.

The potential rating shows the effect of undertaking all of the improvement measures listed within your recommendations report.
