Home Report

1 Waterside Gardens
Bridge of Alford
Alford
AB33 8PG

Single Survey and Mortgage Valuation Report

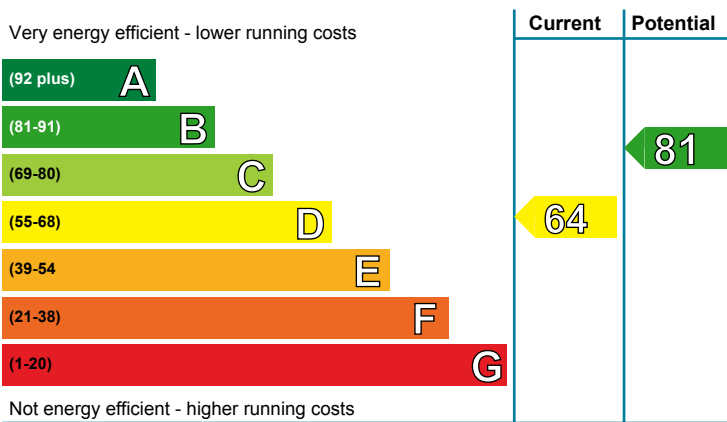
Energy Efficiency Rating

This graph shows the current efficiency of your home, taking into account both energy efficiency and fuel costs. The higher this rating, the lower your fuel bills are likely to be.

Your current rating is **band D (64)**. The average rating for EPCs in Scotland is **band D (61)**.

The potential rating shows the effect of undertaking all of the improvement measures listed within your recommendations report.

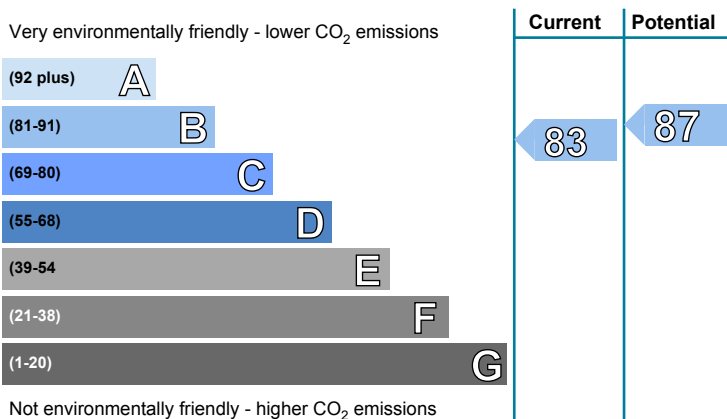
Environmental Impact (CO₂) Rating

This graph shows the effect of your home on the environment in terms of carbon dioxide (CO₂) emissions. The higher the rating, the less impact it has on the environment.

The potential rating shows the effect of undertaking all of the improvement measures listed within your recommendations report.

The average Scottish household produces about 6 tonnes of carbon dioxide every year. Based on this assessment, heating and lighting this home currently produces approximately 2.6 tonnes of carbon dioxide every year. Adopting recommendations in this report can reduce emissions and protect the environment. If you were to install all of these recommendations this could reduce emissions by 0.5 tonnes per year. You could reduce emissions even more by switching to renewable energy sources.
