# Home Report

<b>Property address</b>	Garnock House 1 Aitken Street Dalry KA24 4BX
<b>Customer</b>	Future Property Auctions  <b>** Strictly for sole use of Future Property Auctions (Future Auctions LTD) Not for use with any other marketing agent. Future Property Auctions retains ownership of this report and it may not be used for any other purpose.</b>
<b>Customer address</b>	241 Kilmarnock Road Shawlands Glasgow G41 2JF
<b>Prepared by</b>	Select Surveyors Ltd
<b>Date of Inspection</b>	12 <sup>th</sup> December 2025

<b>Description</b>	<p>The property is a purpose built two storey traditional semi detached house with single storey rear projection.</p> <p>The building is set within the protected Dalry conservation area and has been designated listed Category C status deeming it of regional/local importance and an example of a particular style and period.</p>
<b>Accommodation</b>	<p>The accommodation comprises of :</p> <p>Ground Floor: Entrance hall and foyer, living room with dining area, family room, cloakroom W.C, dining kitchen with pantry, rear hall, utility room.</p> <p>First Floor: Landing and hallway, four bedrooms, study and bathroom.</p>
<b>Gross internal floor area (m<sup

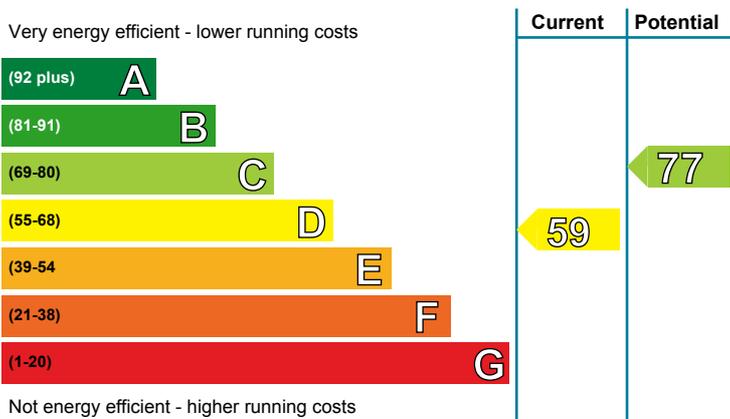
## Energy Efficiency Rating

This graph shows the current efficiency of your home, taking into account both energy efficiency and fuel costs. The higher this rating, the lower your fuel bills are likely to be.

Your current rating is **band D (59)**. The average rating for EPCs in Scotland is **band D (61)**.

The potential rating shows the effect of undertaking all of the improvement measures listed within your recommendations report.

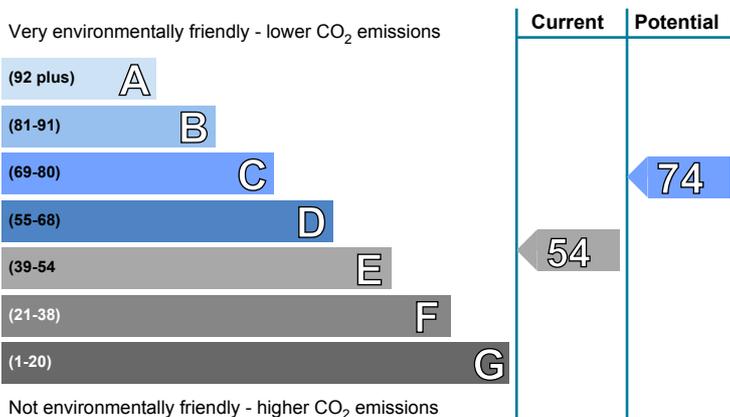
## Environmental Impact (CO<sub>2</sub>) Rating

This graph shows the effect of your home on the environment in terms of carbon dioxide (CO<sub>2</sub>) emissions. The higher the rating, the less impact it has on the environment.
