home report

FLAT 2/2
2 THORNWOOD DRIVE
GLASGOW
G11 7TR

Energy Performance Certificate (EPC)

FLAT 2/2, 2 THORNWOOD DRIVE, GLASGOW, G11 7TR

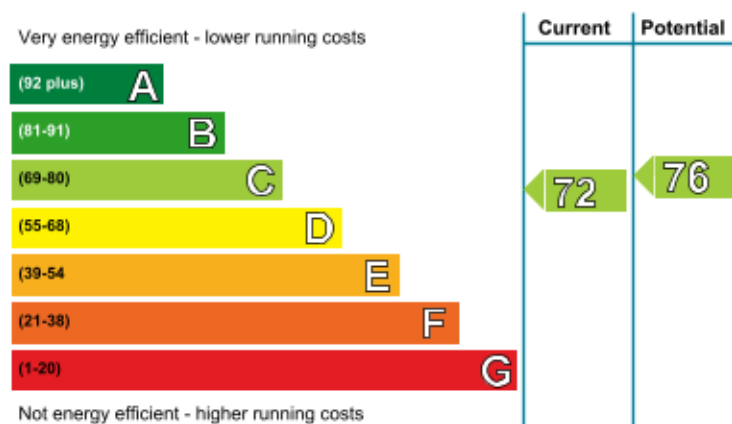
Energy Efficiency Rating

This graph shows the current efficiency of your home, taking into account both energy efficiency and fuel costs. The higher this rating, the lower your fuel bills are likely to be.

Your current rating is **band C (72)**. The average rating for EPCs in Scotland is **band D (61)**.

The potential rating shows the effect of undertaking all of the improvement measures listed within your recommendations report.

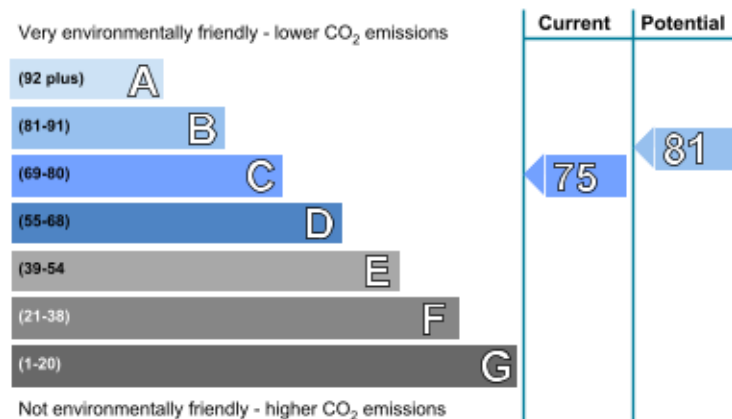
Environmental Impact (CO₂) Rating

This graph shows the effect of your home on the environment in terms of carbon dioxide (CO₂) emissions. The higher the rating, the less impact it has on the environment.

Your current rating is **band C (75)**

The potential rating shows the effect of undertaking all of the improvement measures listed within your recommendations report.

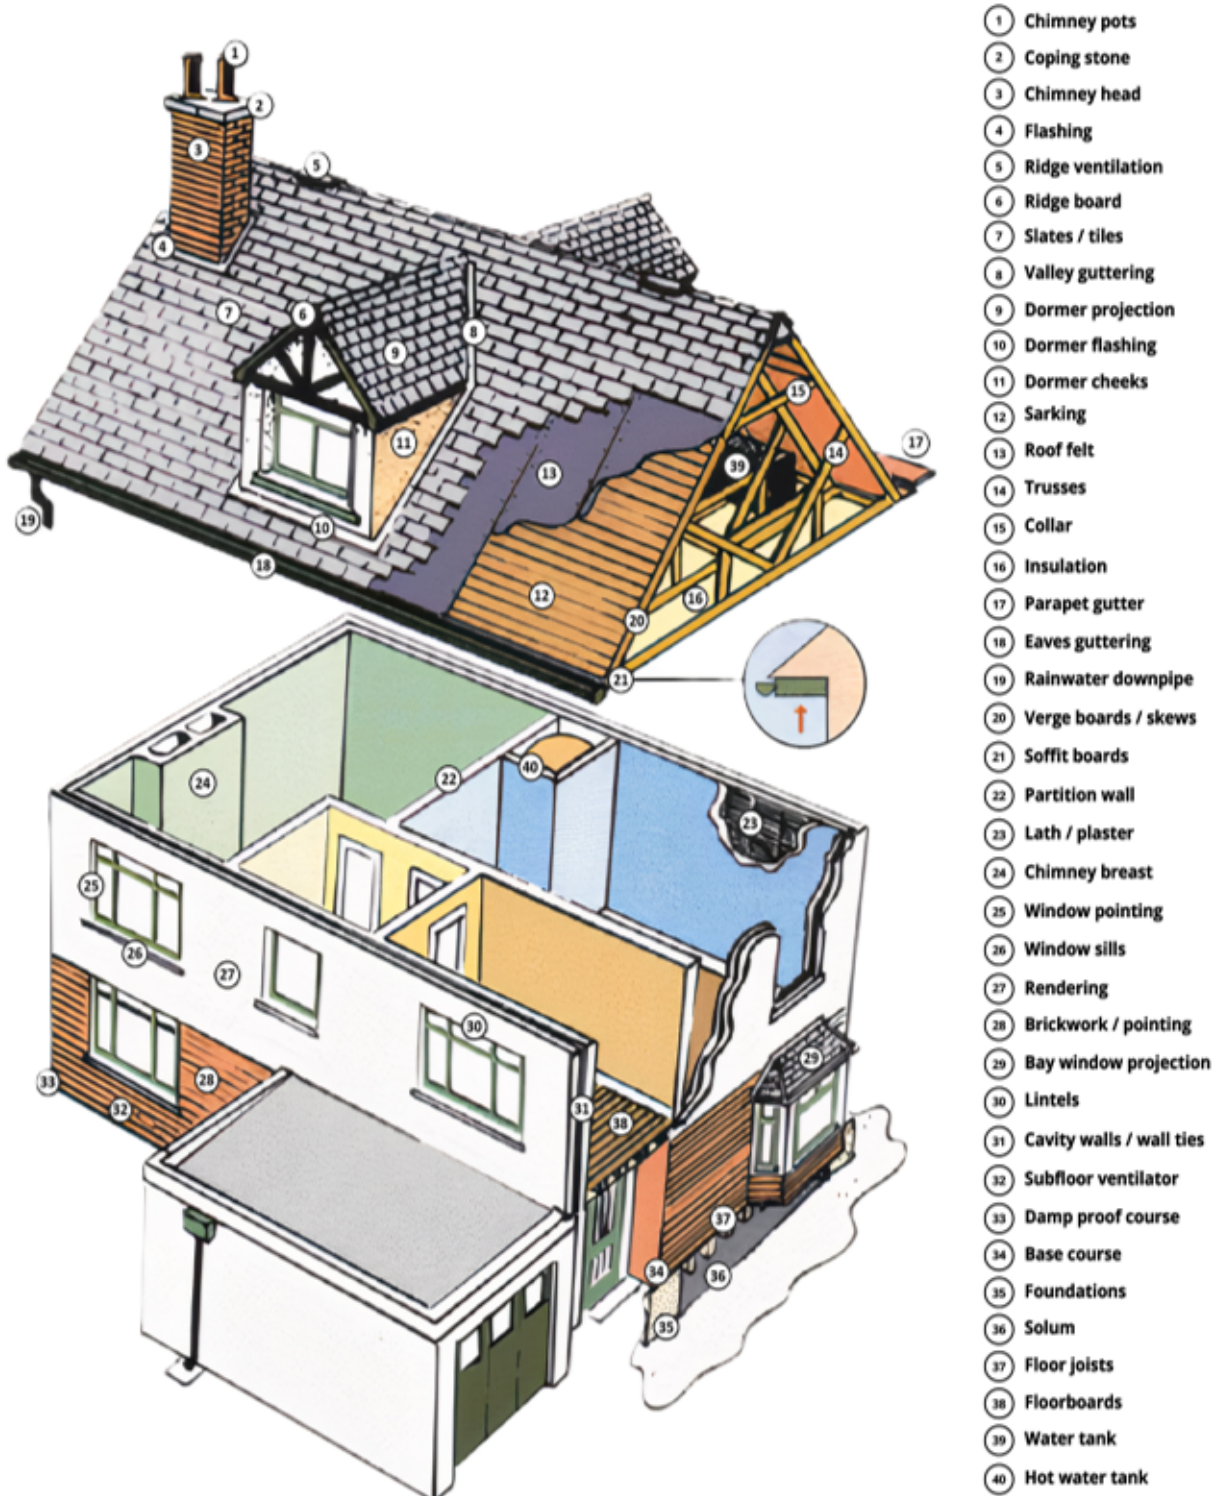
Sectional Diagram showing elements of a typical house

Reference may be made in this report to some or all of the above component parts of the property. This diagram may assist you in locating and understanding these items.
