YOUR ONESURVEY
HOME REPORT

Flat 12
141 Marina Road
Bathgate
EH48 1RS

SINGLE SURVEY

A report on the condition of the property, with categories being rated from 1 to 3.

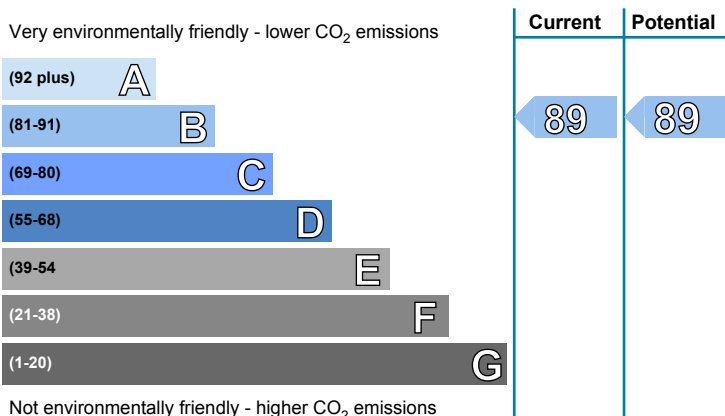
Environmental Impact (CO₂) Rating

This graph shows the effect of your home on the environment in terms of carbon dioxide (CO₂) emissions. The higher the rating, the less impact it has on the environment.
