46/9 Hawthornvale,
Edinburgh,
EH6 4JW

Home Report

Single Survey

Property Address	46/9 Hawthornvale, Edinburgh, EH6 4JW
Reference	1479038
Customer Name	Gary Smith
Date of Inspection	13th March 2026
Surveyor's name, qualifications and office	Charlie Barrett BSc (HONS) MRICS DM Hall LLP Chartered Surveyors 17 Corstorphine Road Edinburgh EH12 6DD tel: 0131 624 6600 email: edinburghresidential@dmhall.co.uk
Prepared By	DM Hall LLP

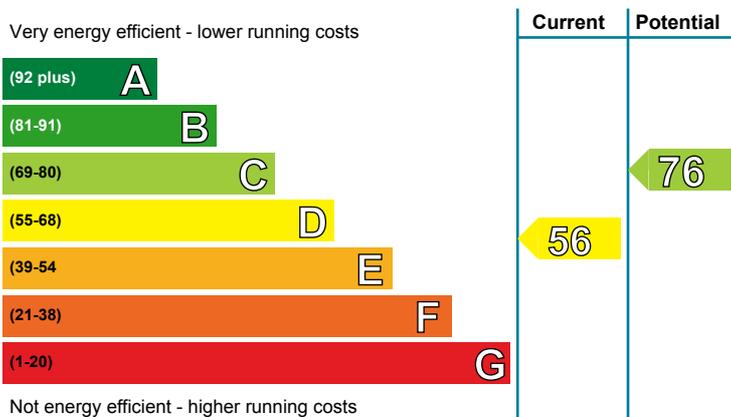
Energy Efficiency Rating

This graph shows the current efficiency of your home, taking into account both energy efficiency and fuel costs. The higher this rating, the lower your fuel bills are likely to be.

Your current rating is **band D (56)**. The average rating for EPCs in Scotland is **band D (61)**.

The potential rating shows the effect of undertaking all of the improvement measures listed within your recommendations report.
