Home Report

Single Survey

survey report on:

Property address	84 Clydesdale Road Bellshill ML4 2QL
Customer	ESKDALE PROPERTIES LLP
Customer address	84 Clydesdale Road Bellshill ML4 2QL
Prepared by	Shepherd Chartered Surveyors
Date of inspection	27/05/2025

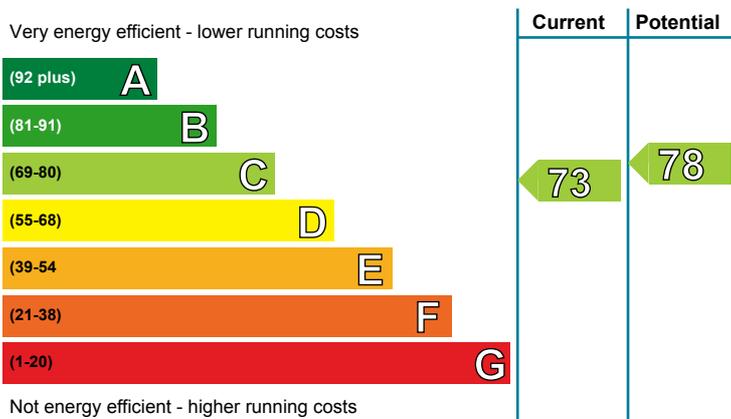
Energy Efficiency Rating

This graph shows the current efficiency of your home, taking into account both energy efficiency and fuel costs. The higher this rating, the lower your fuel bills are likely to be.

Your current rating is **band C (73)**. The average rating for EPCs in Scotland is **band D (61)**.

The potential rating shows the effect of undertaking all of the improvement measures listed within your recommendations report.

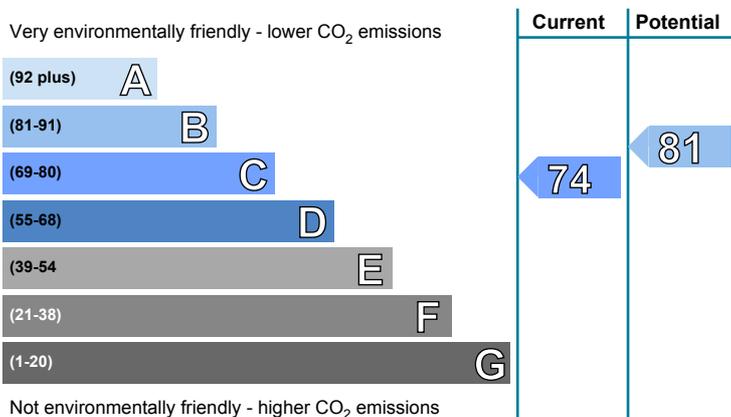
Environmental Impact (CO₂) Rating

This graph shows the effect of your home on the environment in terms of carbon dioxide (CO₂) emissions. The higher the rating, the less impact it has on the environment.
