# Home Report

# Single Survey

| Property address | Clearways Cottage<br>Garelochhead<br>Helensburgh<br>G84 0EL |
| Prepared by | Shepherd Chartered Surveyors |

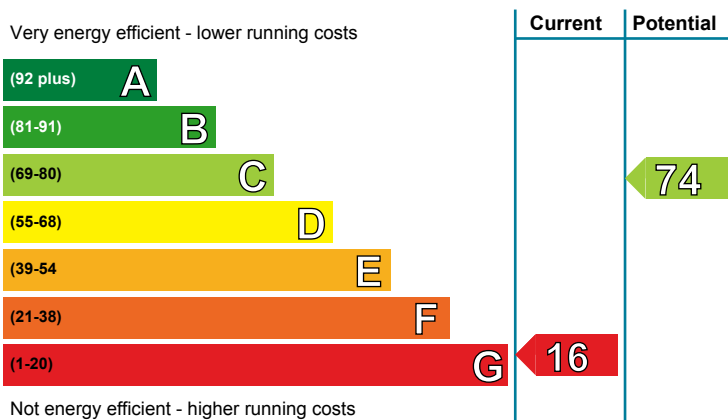
## Energy Efficiency Rating

This graph shows the current efficiency of your home, taking into account both energy efficiency and fuel costs. The higher this rating, the lower your fuel bills are likely to be.

Your current rating is **band G (16)**. The average rating for EPCs in Scotland is **band D (61)**.

The potential rating shows the effect of undertaking all of the improvement measures listed within your recommendations report.

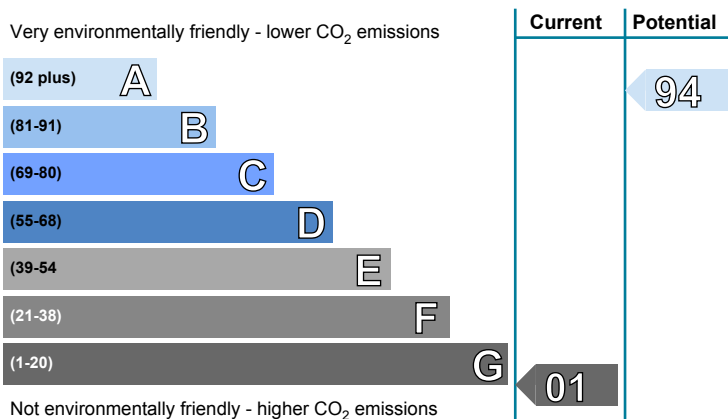
## Environmental Impact (CO<sub>2</sub>) Rating

This graph shows the effect of your home on the environment in terms of carbon dioxide (CO<sub>2</sub>) emissions. The higher the rating, the less impact it has on the environment.
