Single Survey

Property address	5 Lochy Avenue Renfrew PA4 0XT
Customer	Executors of Joseph Riddell
Customer address	5 Lochy Avenue Renfrew PA4 0XT
Prepared by	Shepherd Chartered Surveyors
Date of inspection	04/02/2026

Energy Performance Certificate (EPC)

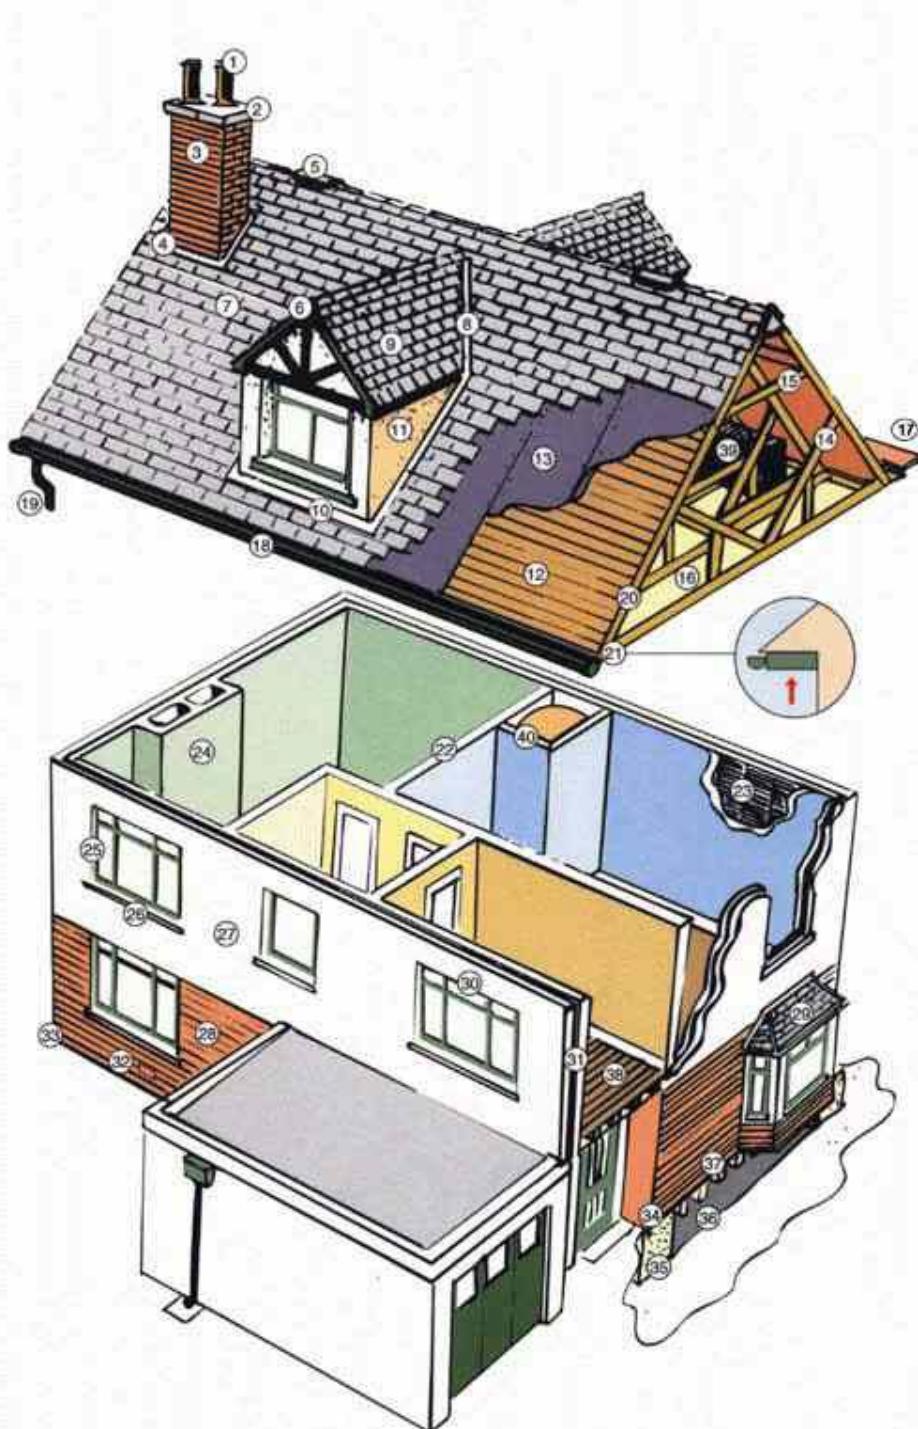
Sectional Diagram showing elements of a typical house

- 1 Chimney pots
- 2 Coping stone
- 3 Chimney head
- 4 Flashing
- 5 Ridge ventilation
- 6 Ridge board
- 7 Slates / tiles
- 8 Valley guttering
- 9 Dormer projection
- 10 Dormer flashing
- 11 Dormer cheeks
- 12 Sarking
- 13 Roof felt
- 14 Trusses
- 15 Collar
- 16 Insulation
- 17 Parapet gutter
- 18 Eaves guttering
- 19 Rainwater downpipe
- 20 Verge boards /skews
- 21 Soffit boards
- 22 Partition wall
- 23 Lath / plaster
- 24 Chimney breast
- 25 Window pointing
- 26 Window sills
- 27 Rendering
- 28 Brickwork / pointing
- 29 Bay window projection
- 30 Lintels
- 31 Cavity walls / wall ties
- 32 Subfloor ventilator
- 33 Damp proof course
- 34 Base course
- 35 Foundations
- 36 Solum
- 37 Floor joists
- 38 Floorboards
- 39 Water tank
- 40 Hot water tank

Reference may be made in this report to some or all of the above component parts of the property. This diagram may assist you in locating and understanding these items.

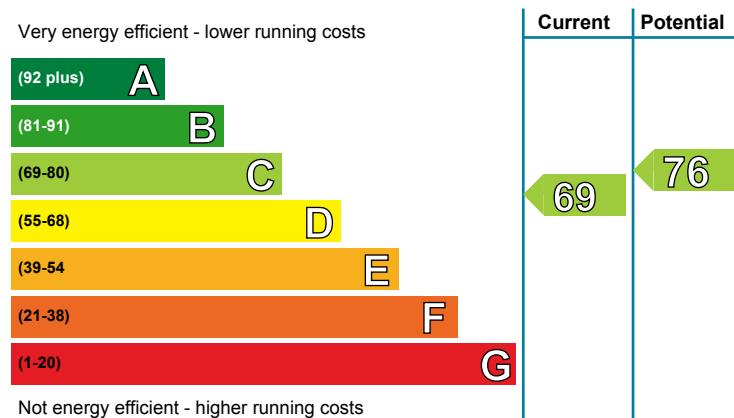
Energy Efficiency Rating

This graph shows the current efficiency of your home, taking into account both energy efficiency and fuel costs. The higher this rating, the lower your fuel bills are likely to be.

Your current rating is **band C (69)**. The average rating for EPCs in Scotland is **band D (61)**.

The potential rating shows the effect of undertaking all of the improvement measures listed within your recommendations report.

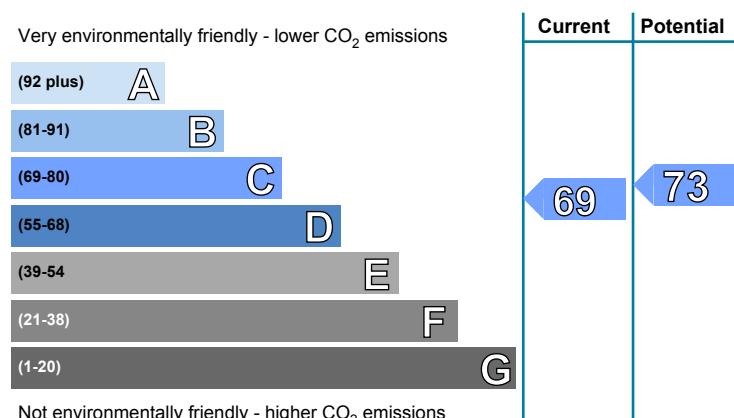
Environmental Impact (CO₂) Rating

This graph shows the effect of your home on the environment in terms of carbon dioxide (CO₂) emissions. The higher the rating, the less impact it has on the environment.
