29 Old Brewery Lane,
ALLOA,
FK10 3GL

Home Report

Single Survey

Property Address	29 Old Brewery Lane, ALLOA, FK10 3GL
Reference	1548112
Customer Name	Darren Punter
Date of Inspection	27th April 2026
Surveyor's name, qualifications and office	Thomas Fergusson MRICS DM Hall LLP Chartered Surveyors Suite 2C 1 Pitt Terrace Stirling FK8 2EZ Tel: 01786 475785 email: stirlingresidential@dmhall.co.uk
Prepared By	DM Hall LLP

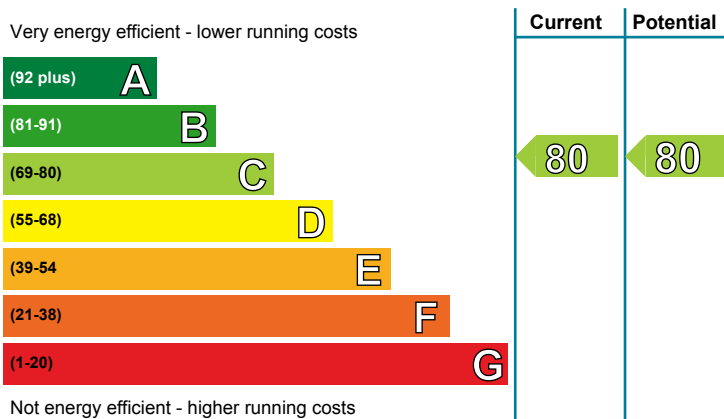
Energy Efficiency Rating

This graph shows the current efficiency of your home, taking into account both energy efficiency and fuel costs. The higher this rating, the lower your fuel bills are likely to be.

Your current rating is **band C (80)**. The average rating for EPCs in Scotland is **band D (61)**.

The potential rating shows the effect of undertaking all of the improvement measures listed within your recommendations report.

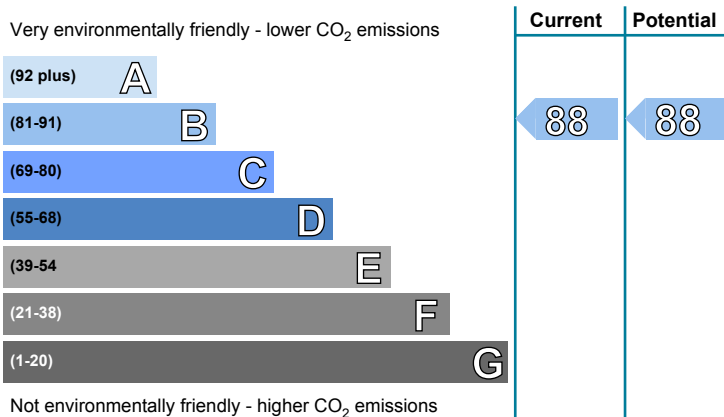
Environmental Impact (CO₂) Rating

This graph shows the effect of your home on the environment in terms of carbon dioxide (CO₂) emissions. The higher the rating, the less impact it has on the environment.
