A H R Crossan and Co

Survey Report

**Mains of Twynholm Cottage,
Twynholm,
Kirkcudbright.
DG6 4PP**

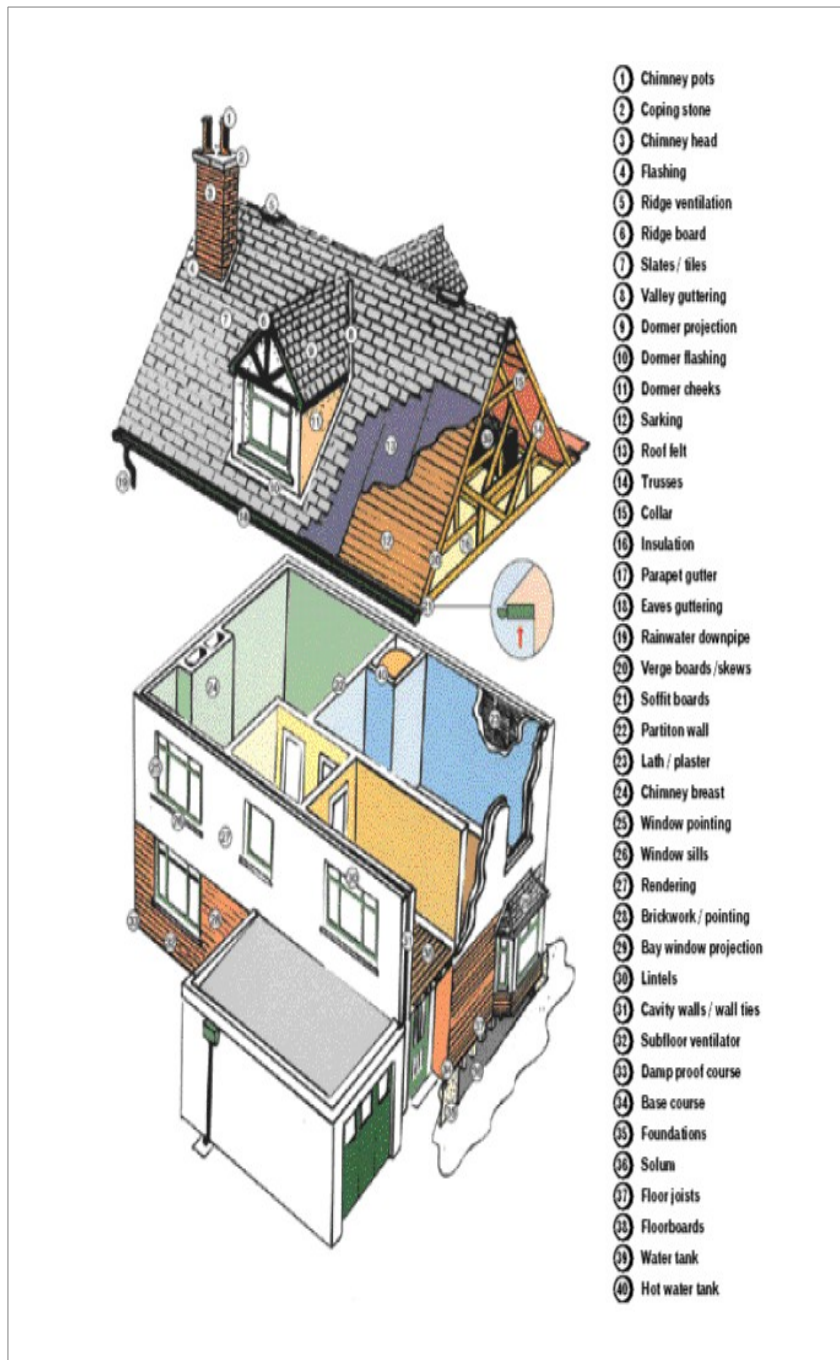
Sectional diagram showing elements of a typical house

Reference may be made in this report to some or all of the above component parts of the property. This diagram may assist you in locating and understanding these terms.
