# Home Report

# Single Survey

<b>Property address</b>	12 Colston Path Bishopbriggs Glasgow G64 2BL
<b>Customer</b>	
<b>Customer address</b>	12 Colston Path Bishopbriggs Glasgow G64 2BL
<b>Prepared by</b>	Shepherd Chartered Surveyors
<b>Date of inspection</b>	26/01/2026

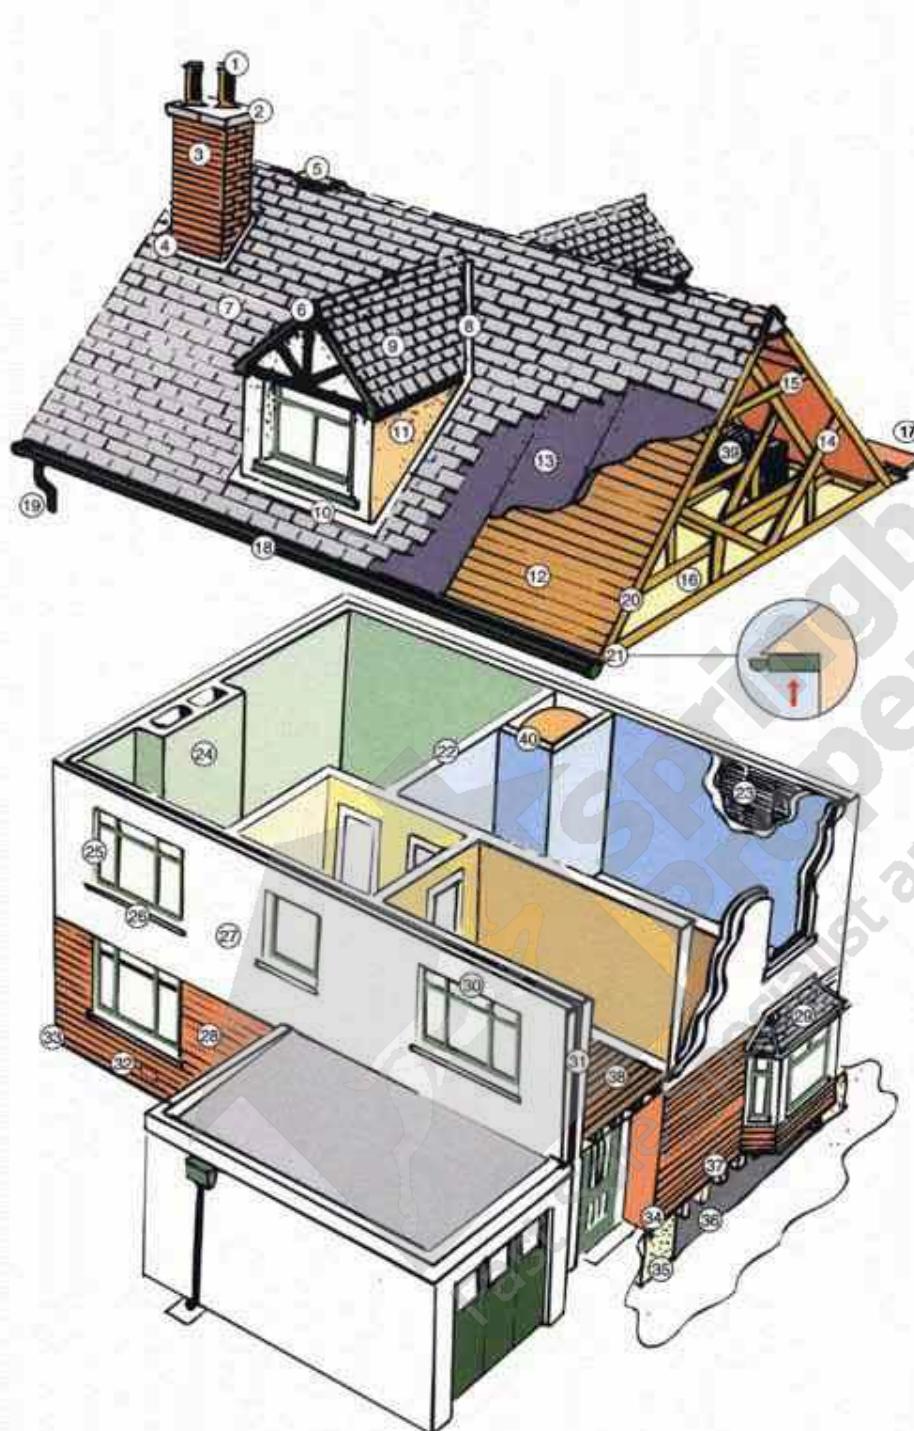
## Sectional Diagram showing elements of a typical house

- 1 Chimney pots
- 2 Coping stone
- 3 Chimney head
- 4 Flashing
- 5 Ridge ventilation
- 6 Ridge board
- 7 Slates / tiles
- 8 Valley guttering
- 9 Dormer projection
- 10 Dormer flashing
- 11 Dormer cheeks
- 12 Sarking
- 13 Roof felt
- 14 Trusses
- 15 Collar
- 16 Insulation
- 17 Parapet gutter
- 18 Eaves guttering
- 19 Rainwater downpipe
- 20 Verge boards /skews
- 21 Soffit boards
- 22 Partition wall
- 23 Lath / plaster
- 24 Chimney breast
- 25 Window pointing
- 26 Window sills
- 27 Rendering
- 28 Brickwork / pointing
- 29 Bay window projection
- 30 Lintels
- 31 Cavity walls / wall ties
- 32 Subfloor ventilator
- 33 Damp proof course
- 34 Base course
- 35 Foundations
- 36 Solum
- 37 Floor joists
- 38 Floorboards
- 39 Water tank
- 40 Hot water tank

Reference may be made in this report to some or all of the above component parts of the property. This diagram may assist you in locating and understanding these items.

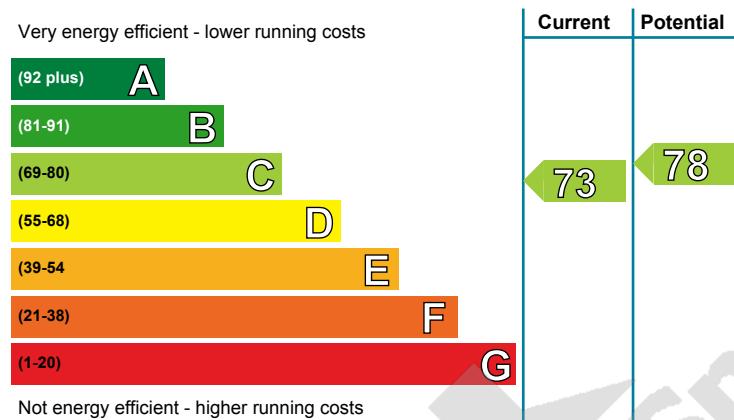
## Energy Efficiency Rating

This graph shows the current efficiency of your home, taking into account both energy efficiency and fuel costs. The higher this rating, the lower your fuel bills are likely to be.

Your current rating is **band C (73)**. The average rating for EPCs in Scotland is **band D (61)**.

The potential rating shows the effect of undertaking all of the improvement measures listed within your recommendations report.

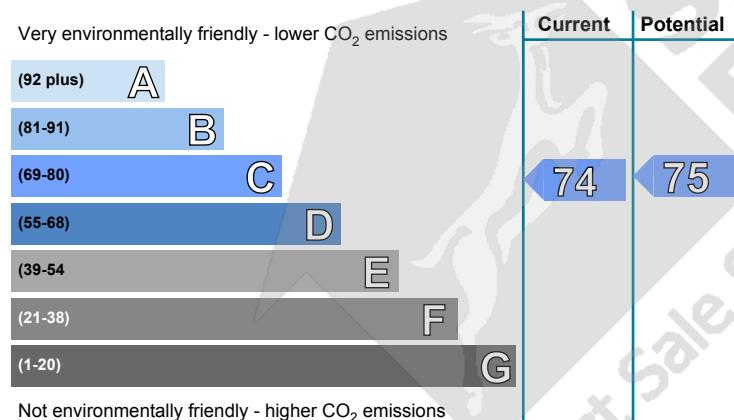
## Environmental Impact (CO<sub>2</sub>) Rating

This graph shows the effect of your home on the environment in terms of carbon dioxide (CO<sub>2</sub>) emissions. The higher the rating, the less impact it has on the environment.
