# HOME REPORT

5 Broomhead Park,  
Dunfermline,  
KY12 0PT

# Single Survey

## Survey Report on:

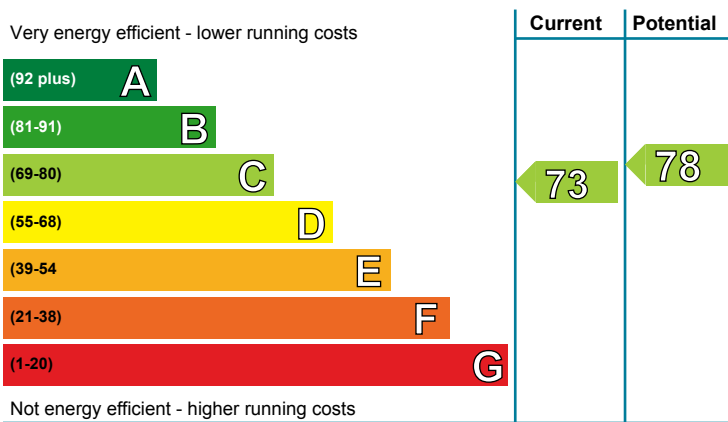
## Energy Efficiency Rating

This graph shows the current efficiency of your home, taking into account both energy efficiency and fuel costs. The higher this rating, the lower your fuel bills are likely to be.

Your current rating is **band C (73)**. The average rating for EPCs in Scotland is **band D (61)**.

The potential rating shows the effect of undertaking all of the improvement measures listed within your recommendations report.

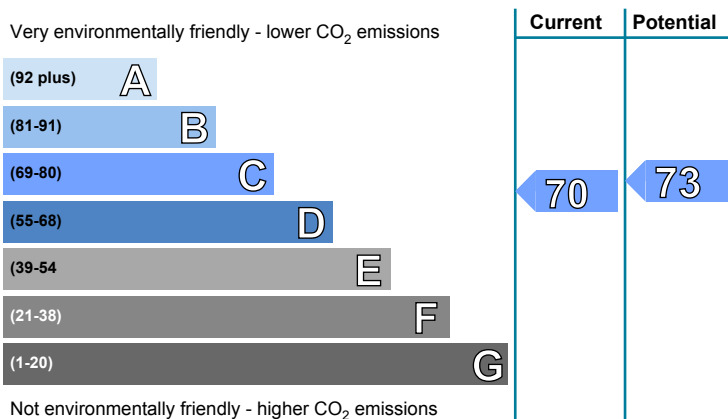
## Environmental Impact (CO<sub>2</sub>) Rating

This graph shows the effect of your home on the environment in terms of carbon dioxide (CO<sub>2</sub>) emissions. The higher the rating, the less impact it has on the environment.
