# Home Report

Floshpark  
Cummertrees Annan DG12 5PZ

# Single Survey

<b>Description</b>	The subjects comprise a detached bungalow.
--------------------	--

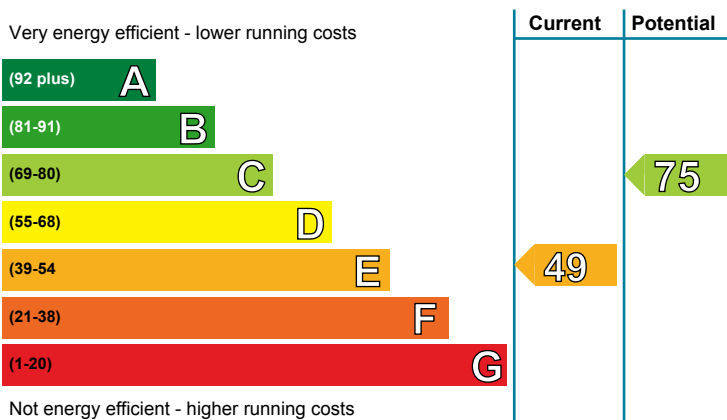
## Energy Efficiency Rating

This graph shows the current efficiency of your home, taking into account both energy efficiency and fuel costs. The higher this rating, the lower your fuel bills are likely to be.

Your current rating is **band E (49)**. The average rating for EPCs in Scotland is **band D (61)**.

The potential rating shows the effect of undertaking all of the improvement measures listed within your recommendations report.

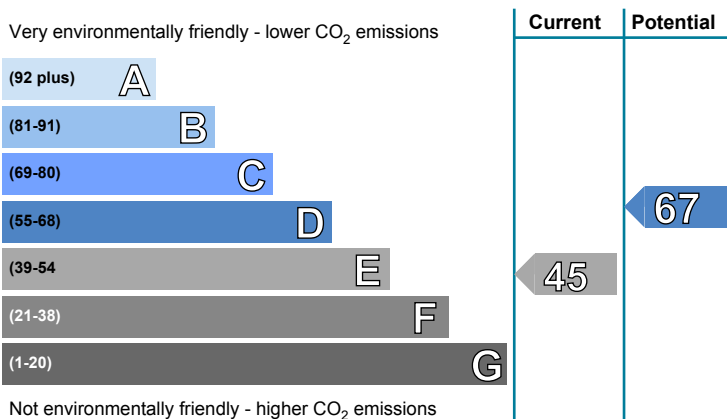
## Environmental Impact (CO<sub>2</sub>) Rating

This graph shows the effect of your home on the environment in terms of carbon dioxide (CO<sub>2</sub>) emissions. The higher the rating, the less impact it has on the environment.
