YOUR ONESURVEY HOME REPORT

11 Red Squirrel Way
Liff
Dundee
DD2 5SU

SINGLE SURVEY

Single Survey

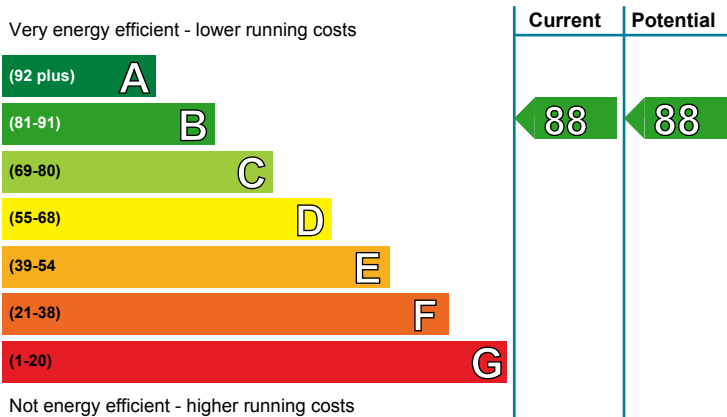
Energy Efficiency Rating

This graph shows the current efficiency of your home, taking into account both energy efficiency and fuel costs. The higher this rating, the lower your fuel bills are likely to be.

Your current rating is **band B (88)**. The average rating for EPCs in Scotland is **band D (61)**.

The potential rating shows the effect of undertaking all of the improvement measures listed within your recommendations report.

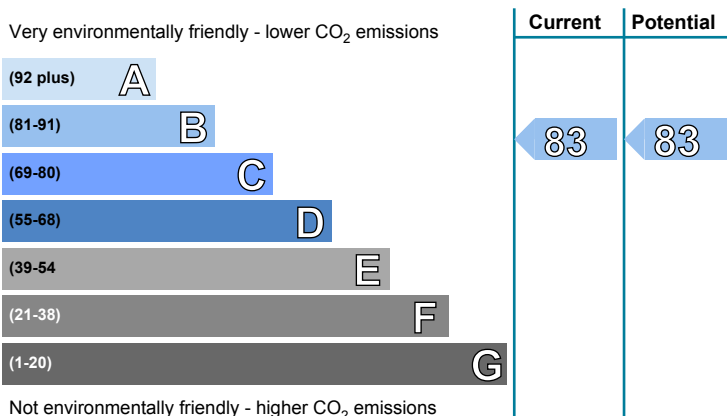
Environmental Impact (CO₂) Rating

This graph shows the effect of your home on the environment in terms of carbon dioxide (CO₂) emissions. The higher the rating, the less impact it has on the environment.
