1 Garden Terrace,
FALKIRK,
FK1 1RL

Home Report

Single Survey

Property Address	1 Garden Terrace, FALKIRK, FK1 1RL
Reference	1633786
Customer Name	Hugh Dyer
Date of Inspection	17th June 2026
Surveyor's name, qualifications and office	Victoria Connell DM Hall LLP Chartered Surveyors Unit 6A, The Courtyard Callendar Business Park Falkirk FK1 1XR Tel: 01324 628321 email: centralresidential@dmhall.co.uk
Prepared By	DM Hall LLP

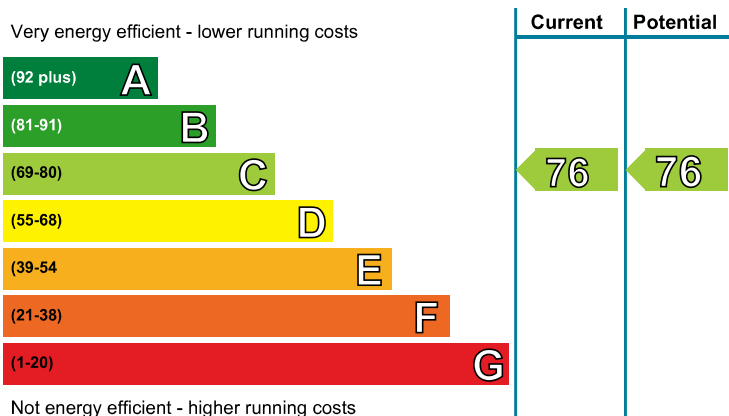
Energy Efficiency Rating

This graph shows the current efficiency of your home, taking into account both energy efficiency and fuel costs. The higher this rating, the lower your fuel bills are likely to be.

Your current rating is **band C (76)**. The average rating for EPCs in Scotland is **band D (61)**.

The potential rating shows the effect of undertaking all of the improvement measures listed within your recommendations report.

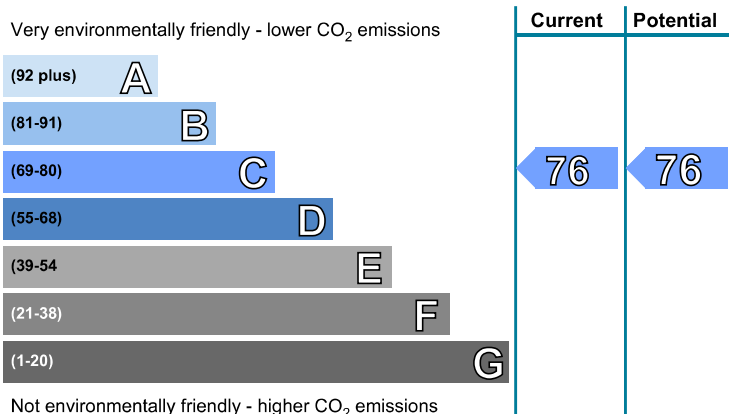
Environmental Impact (CO₂) Rating

This graph shows the effect of your home on the environment in terms of carbon dioxide (CO₂) emissions. The higher the rating, the less impact it has on the environment.
