# Home Report

# Single Survey

<b>Property address</b>	17 Kinglass Road Bearsden Glasgow G61 1JR
<b>Customer</b>	[REDACTED]
<b>Customer address</b>	17 Kinglass Road Bearsden Glasgow G61 1JR
<b>Prepared by</b>	Shepherd Chartered Surveyors
<b>Date of inspection</b>	27/04/2026

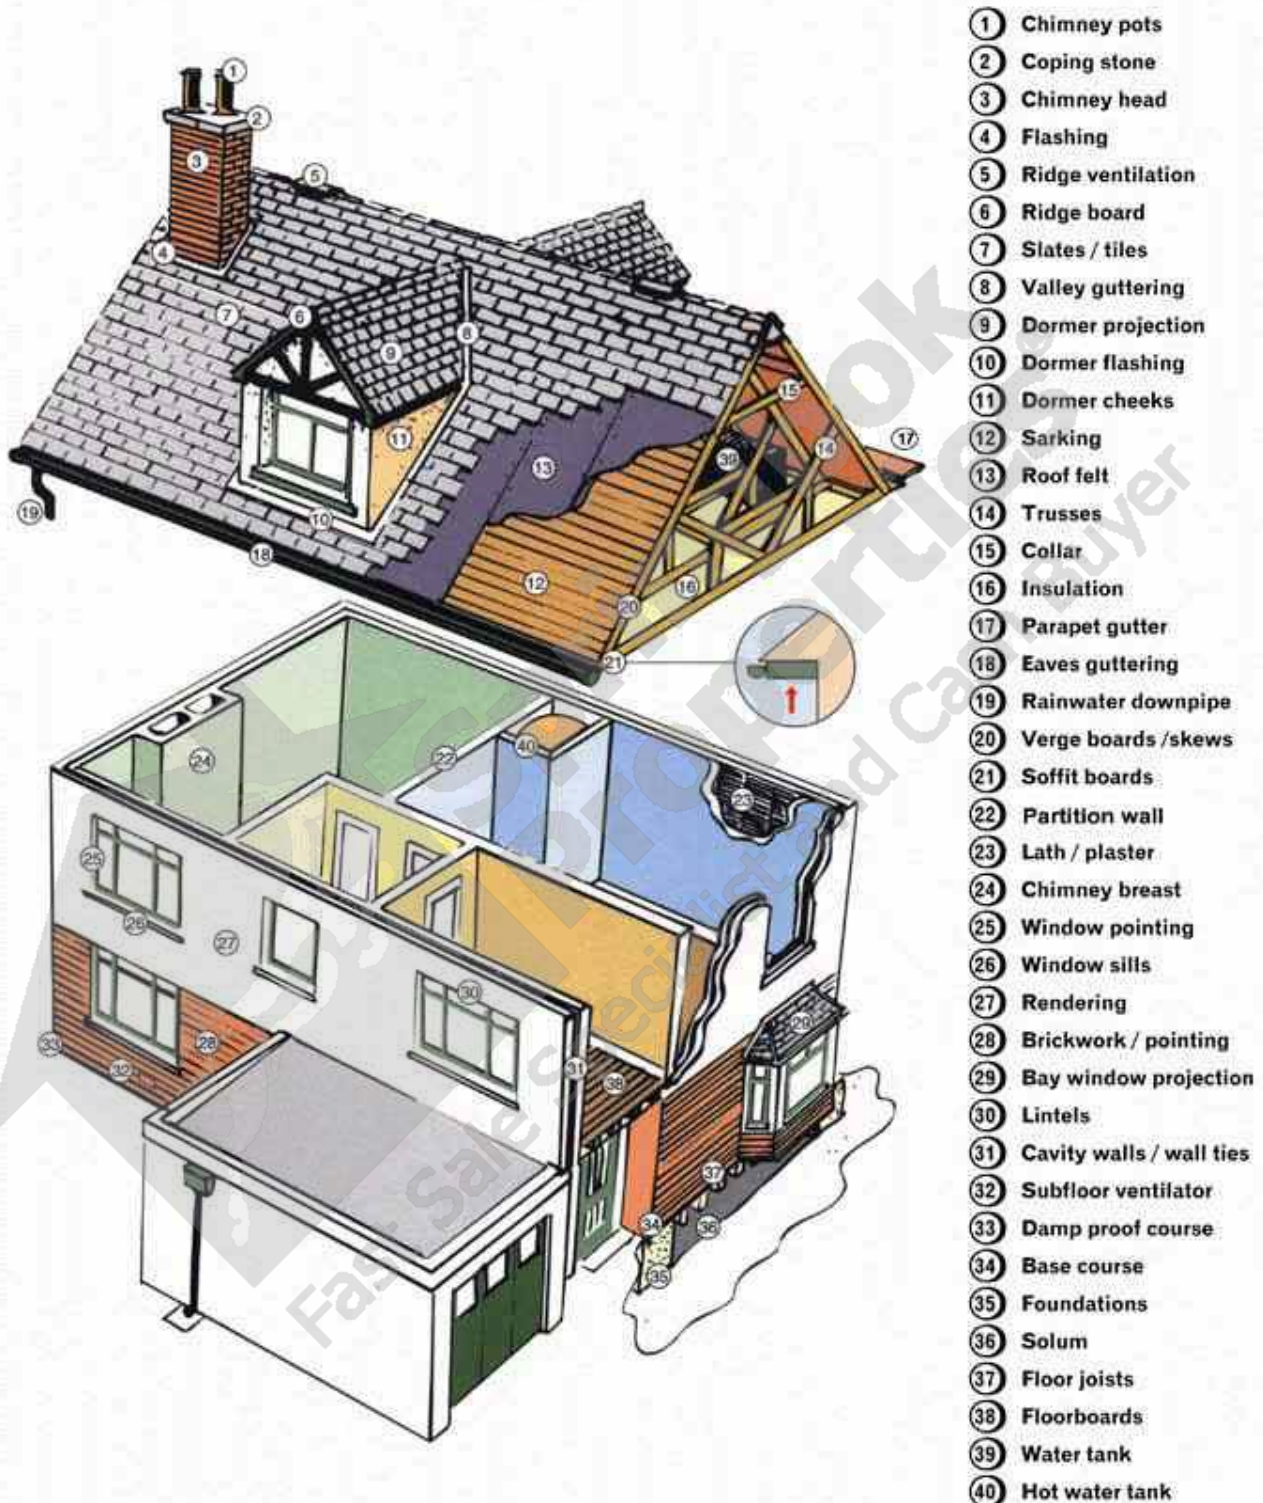
## Sectional Diagram showing elements of a typical house

Reference may be made in this report to some or all of the above component parts of the property. This diagram may assist you in locating and understanding these items.
