Home Report

Scottish Single Survey

Property address	19 Academy Street Tain IV19 1ED
Customer	Mr Leslie Fraser
Customer address	19 Academy Street Tain IV19 1ED
Prepared by	Shepherd Chartered Surveyors
Date of inspection	21/04/2026

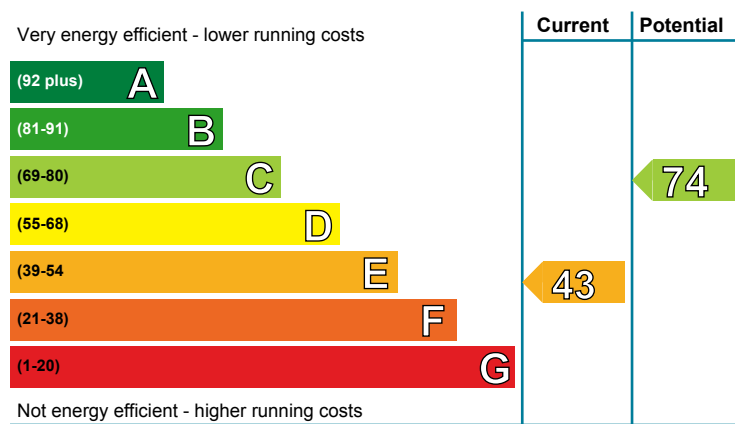
Energy Efficiency Rating

This graph shows the current efficiency of your home, taking into account both energy efficiency and fuel costs. The higher this rating, the lower your fuel bills are likely to be.

Your current rating is **band E (43)**. The average rating for EPCs in Scotland is **band D (61)**.

The potential rating shows the effect of undertaking all of the improvement measures listed within your recommendations report.
