home report

14A GREENHEAD AVENUE
STEVENSTON
KA20 4EA

Energy Performance Certificate (EPC)

Single Survey

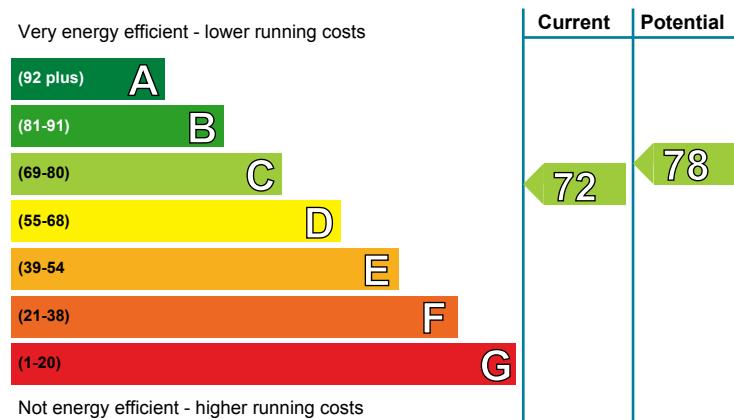
Energy Efficiency Rating

This graph shows the current efficiency of your home, taking into account both energy efficiency and fuel costs. The higher this rating, the lower your fuel bills are likely to be.

Your current rating is **band C (72)**. The average rating for EPCs in Scotland is **band D (61)**.

The potential rating shows the effect of undertaking all of the improvement measures listed within your recommendations report.

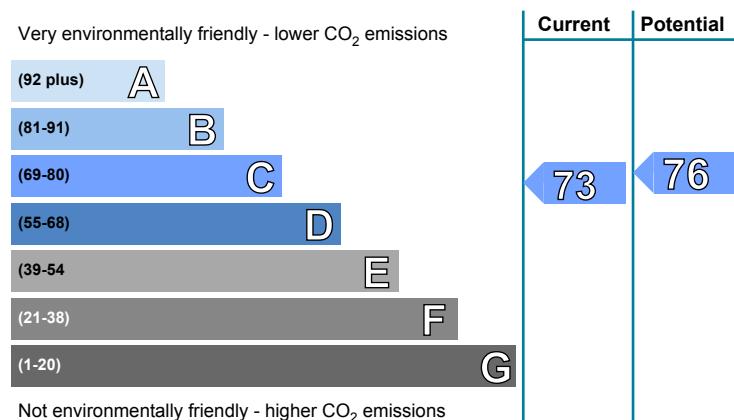
Environmental Impact (CO₂) Rating

This graph shows the effect of your home on the environment in terms of carbon dioxide (CO₂) emissions. The higher the rating, the less impact it has on the environment.

Your current rating is **band C (73)**

The potential rating shows the effect of undertaking all of the improvement measures listed within your recommendations report.
