Home Report

Scottish Single Survey

Property address	7a Aitken Street Largs KA30 8AT
Customer	Mr MacDonald
Customer address	7a Aitken Street Largs KA30 8AT
Prepared by	Shepherd Chartered Surveyors
Date of inspection	16/06/2026

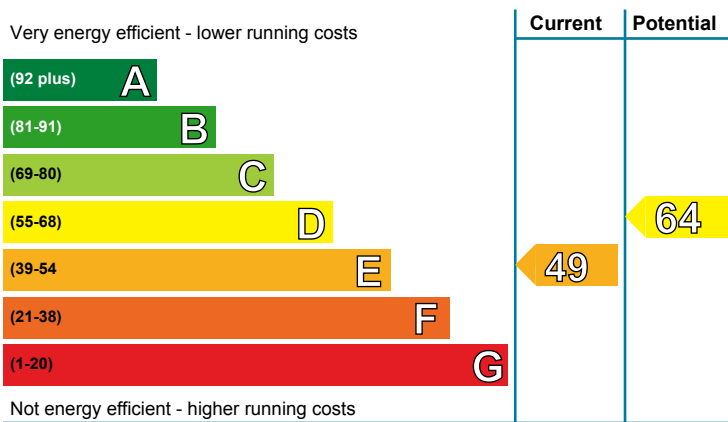
Energy Efficiency Rating

This graph shows the current efficiency of your home, taking into account both energy efficiency and fuel costs. The higher this rating, the lower your fuel bills are likely to be.

Your current rating is **band E (49)**. The average rating for EPCs in Scotland is **band D (61)**.

The potential rating shows the effect of undertaking all of the improvement measures listed within your recommendations report.

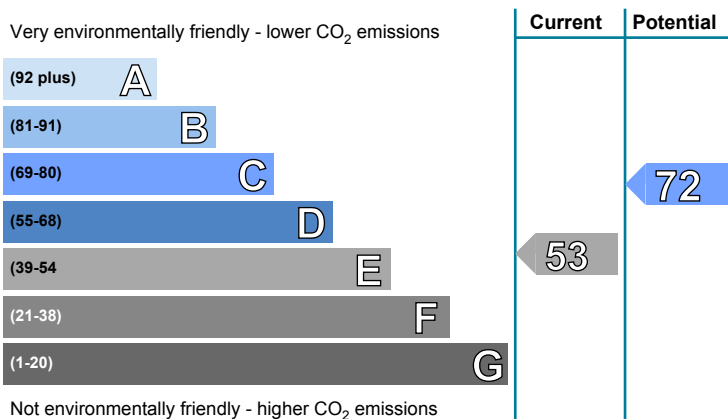
Environmental Impact (CO₂) Rating

This graph shows the effect of your home on the environment in terms of carbon dioxide (CO₂) emissions. The higher the rating, the less impact it has on the environment.
