# Home Report

6 Jedburgh Road  
Dundee DD2 1SS

# Single Survey

<b>Property Address</b>	6 Jedburgh Road Dundee DD2 1SS
<b>Customer</b>	Frances Higgins
<b>Prepared by</b>	Graham + Sibbald Property Consultants Limited
<b>Date of Inspection</b>	22/06/2026

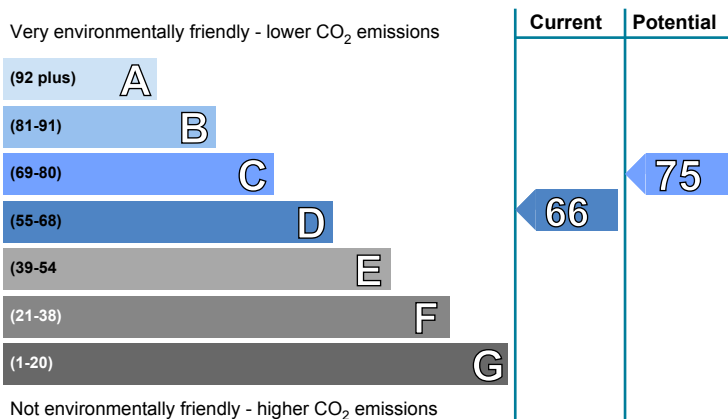
## Environmental Impact (CO<sub>2</sub>) Rating

This graph shows the effect of your home on the environment in terms of carbon dioxide (CO<sub>2</sub>) emissions. The higher the rating, the less impact it has on the environment.
