Home Report

Single Survey

Property address	31 Oswald Road Kirkcaldy KY1 3JE
Customer	
Customer address	31 Oswald Road Kirkcaldy KY1 3JE
Prepared by	Shepherd Chartered Surveyors
Date of inspection	09/01/2026

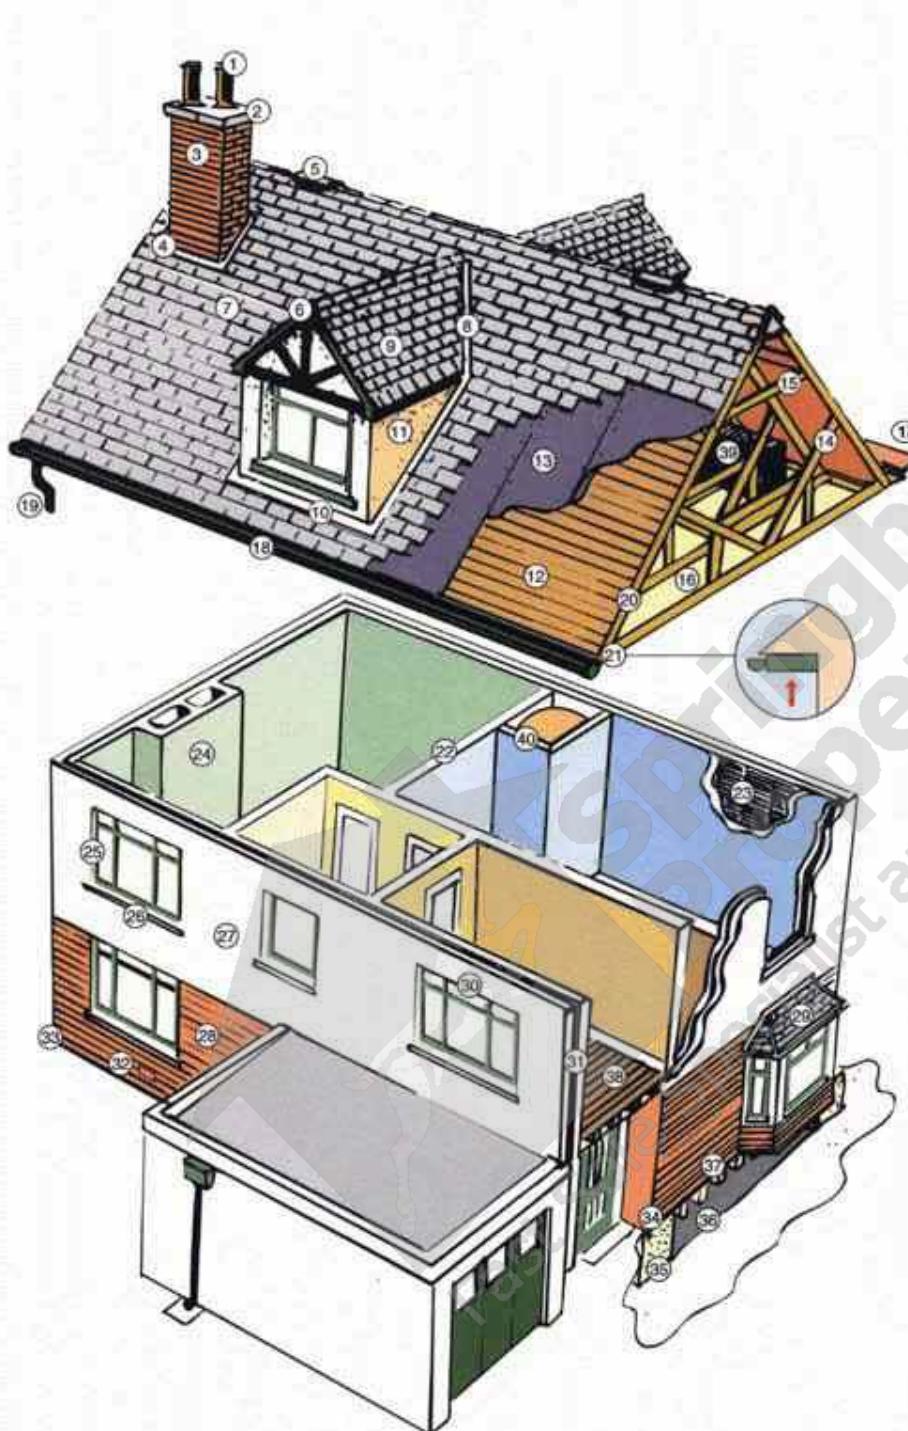
Sectional Diagram showing elements of a typical house

- 1 Chimney pots
- 2 Coping stone
- 3 Chimney head
- 4 Flashing
- 5 Ridge ventilation
- 6 Ridge board
- 7 Slates / tiles
- 8 Valley guttering
- 9 Dormer projection
- 10 Dormer flashing
- 11 Dormer cheeks
- 12 Sarking
- 13 Roof felt
- 14 Trusses
- 15 Collar
- 16 Insulation
- 17 Parapet gutter
- 18 Eaves guttering
- 19 Rainwater downpipe
- 20 Verge boards /skews
- 21 Soffit boards
- 22 Partition wall
- 23 Lath / plaster
- 24 Chimney breast
- 25 Window pointing
- 26 Window sills
- 27 Rendering
- 28 Brickwork / pointing
- 29 Bay window projection
- 30 Lintels
- 31 Cavity walls / wall ties
- 32 Subfloor ventilator
- 33 Damp proof course
- 34 Base course
- 35 Foundations
- 36 Solum
- 37 Floor joists
- 38 Floorboards
- 39 Water tank
- 40 Hot water tank

Reference may be made in this report to some or all of the above component parts of the property. This diagram may assist you in locating and understanding these items.
