Home Report

FLAT 6 , 7 CROOKSTON COURT, LARBERT, FK5 4XE

Single Survey

Property address	FLAT 6 7 CROOKSTON COURT LARBERT FALKIRK FK5 4XE
Customer	W McGUCKIN
Customer address	
Prepared by	Home Report Company
Date of Inspection	3 rd March 2026

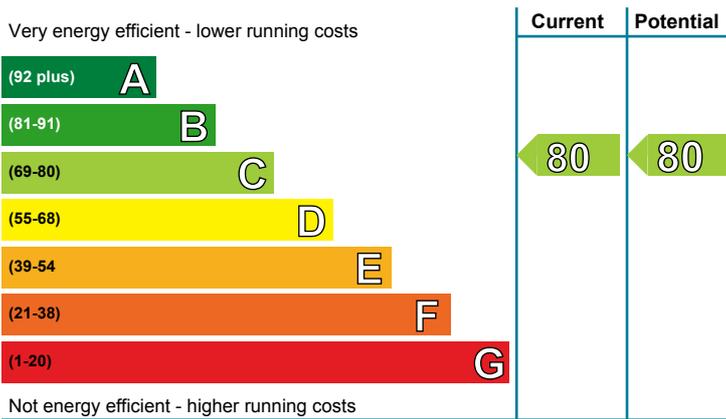
Energy Efficiency Rating

This graph shows the current efficiency of your home, taking into account both energy efficiency and fuel costs. The higher this rating, the lower your fuel bills are likely to be.

Your current rating is **band C (80)**. The average rating for EPCs in Scotland is **band D (61)**.

The potential rating shows the effect of undertaking all of the improvement measures listed within your recommendations report.

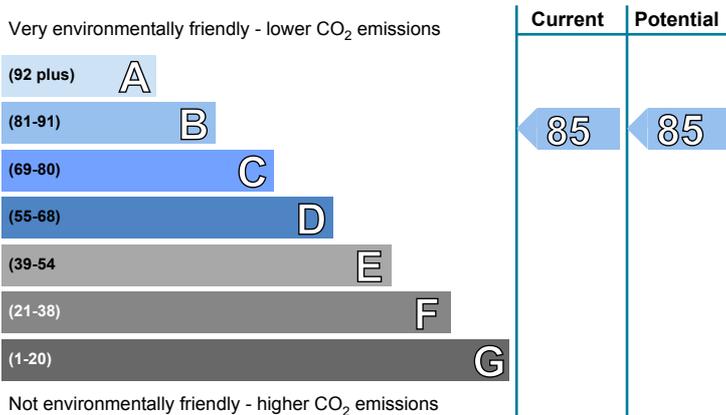
Environmental Impact (CO₂) Rating

This graph shows the effect of your home on the environment in terms of carbon dioxide (CO₂) emissions. The higher the rating, the less impact it has on the environment.

The potential rating shows the effect of undertaking all of the improvement measures listed within your recommendations report.
