Home Report

Dwelling Address	4 Balcarres Terrace, ALFORD, AB33 8FN
Reference	008657
Assessment Date	04/06/2026
Submission Date	07/06/2026
Property Type	End-Terrace House
Total Floor Area	80 m ²

Single Survey

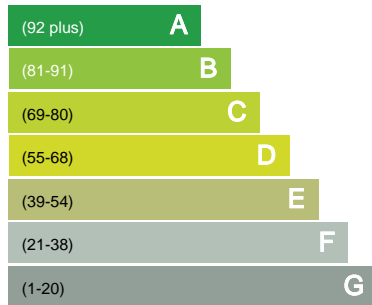
Carbon Dioxide (CO₂) Emissions Rating

Very environmentally friendly - lower CO₂ emissions

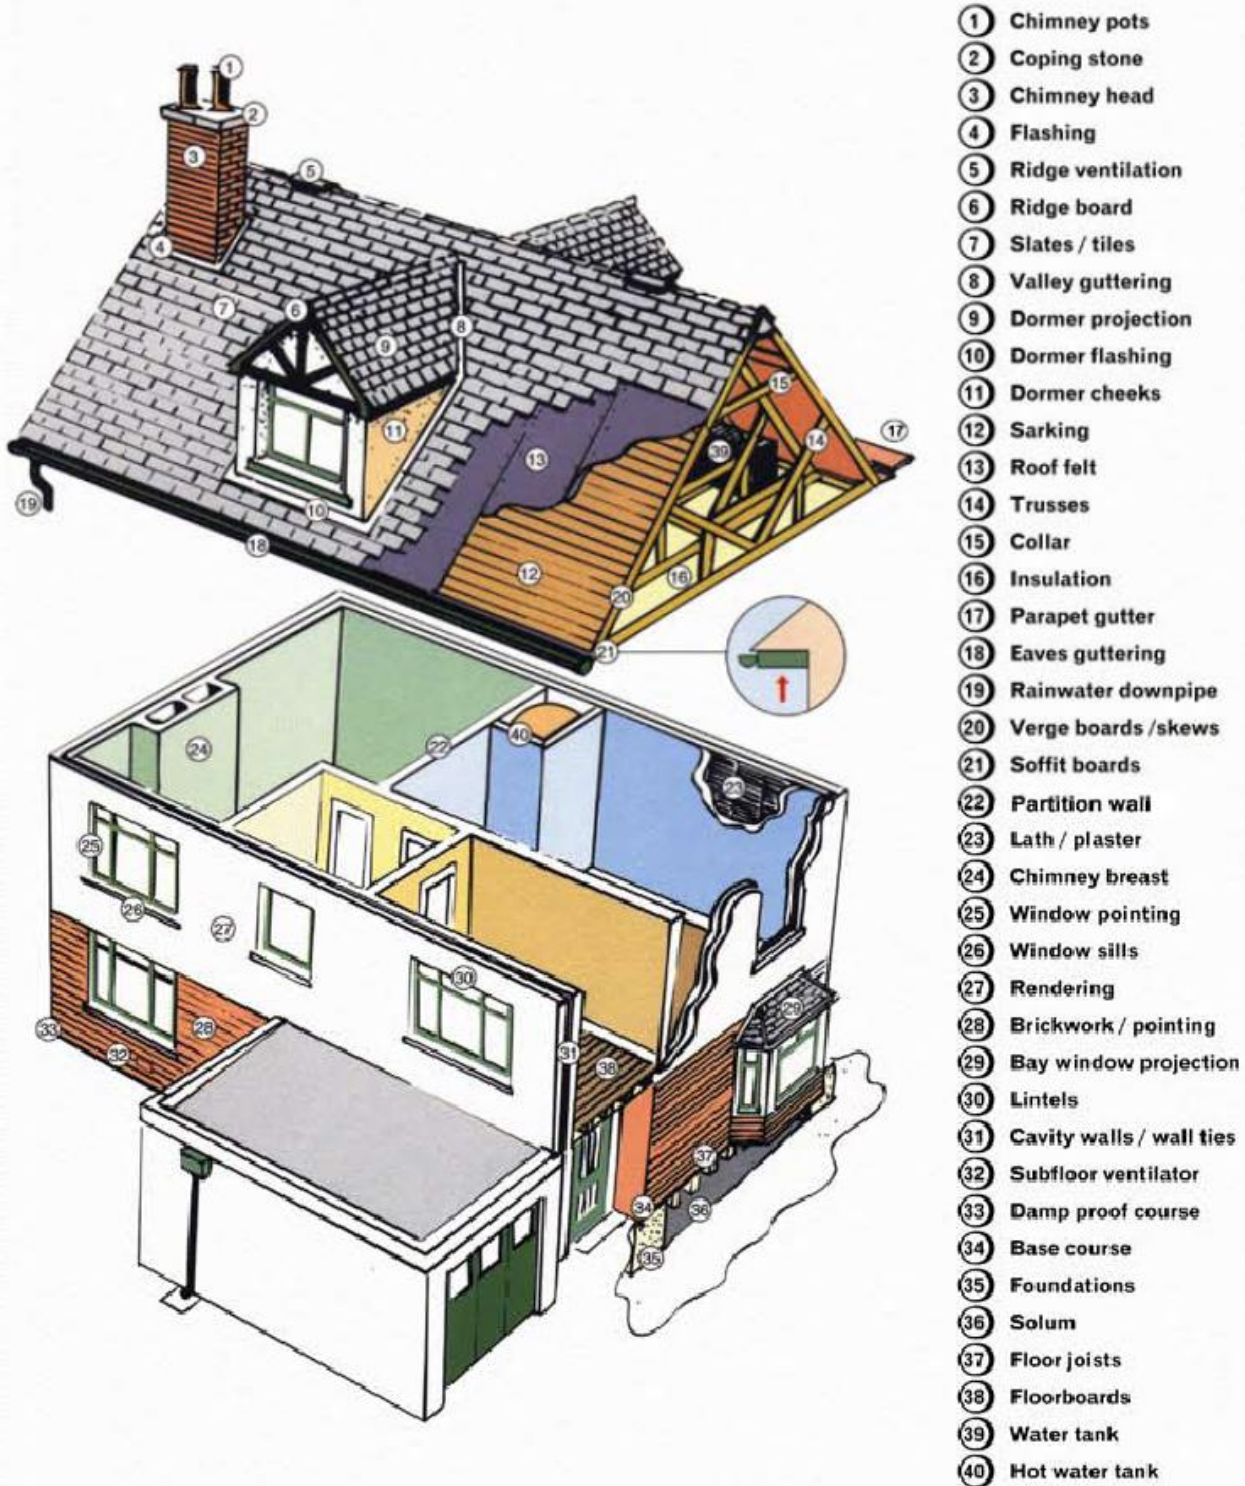
Sectional Diagram showing elements of a typical house

Reference may be made in this report to some or all of the above component parts of the property. This diagram may assist you in locating and understanding these items.
