# Home Report

# Single Survey

| Property address | 54 Morvich Way<br>Inverness<br>IV2 4PJ |
| Prepared by | Shepherd Chartered Surveyors |

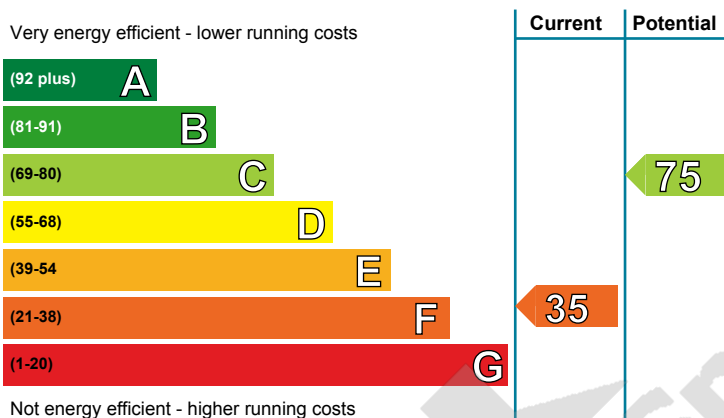
## Energy Efficiency Rating

This graph shows the current efficiency of your home, taking into account both energy efficiency and fuel costs. The higher this rating, the lower your fuel bills are likely to be.

The potential rating shows the effect of undertaking all of the improvement measures listed within your recommendations report.

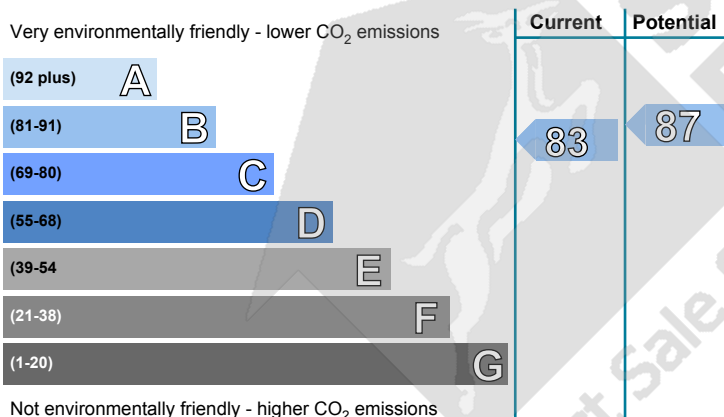
## Environmental Impact (CO<sub>2</sub>) Rating

This graph shows the effect of your home on the environment in terms of carbon dioxide (CO<sub>2</sub>) emissions. The higher the rating, the less impact it has on the environment.
