# HOME REPORT

231 Curtis Avenue  
Glasgow  
G44 4NW

# SINGLE SURVEY

# Single Survey

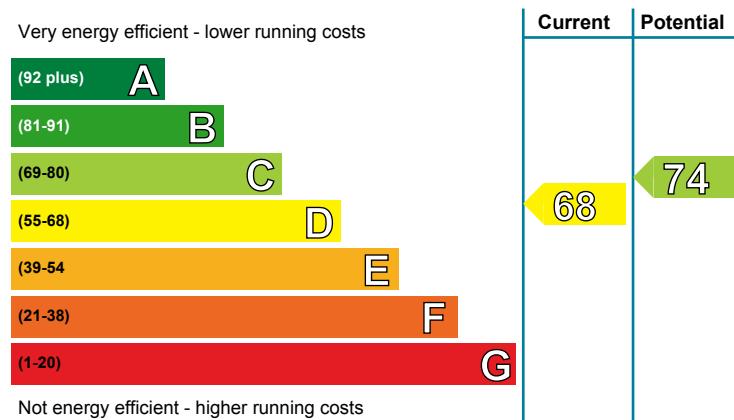
## Energy Efficiency Rating

This graph shows the current efficiency of your home, taking into account both energy efficiency and fuel costs. The higher this rating, the lower your fuel bills are likely to be.

Your current rating is **band D (68)**. The average rating for EPCs in Scotland is **band D (61)**.

The potential rating shows the effect of undertaking all of the improvement measures listed within your recommendations report.

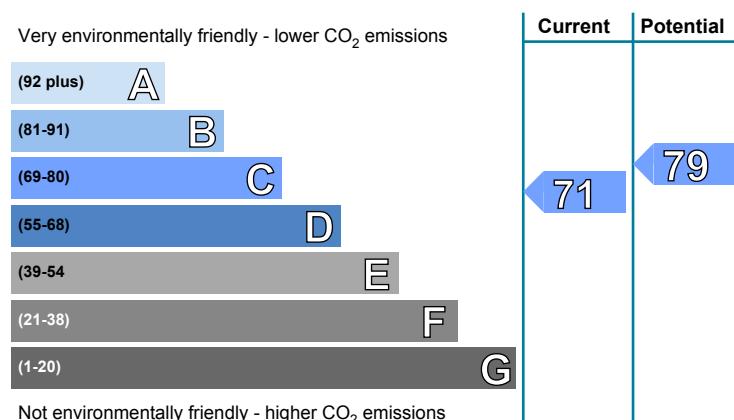
## Environmental Impact (CO<sub>2</sub>) Rating

This graph shows the effect of your home on the environment in terms of carbon dioxide (CO<sub>2</sub>) emissions. The higher the rating, the less impact it has on the environment.
