# Home Report

# Single Survey

| Property address | Hilltown Farm House<br>Woolmet<br>Dalkeith<br>EH22 1SG |
| Prepared by | Shepherd Chartered Surveyors |

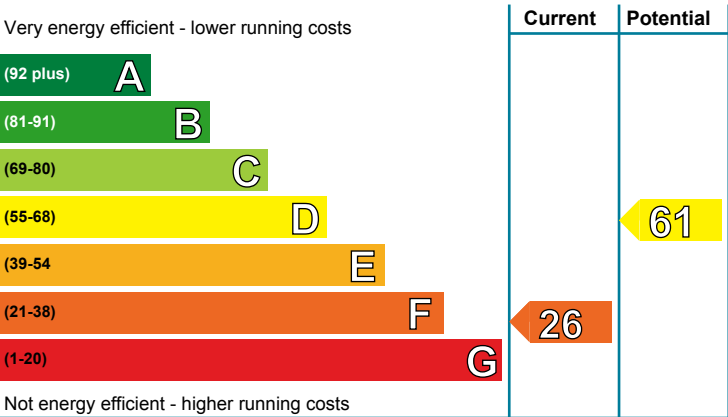
**Energy Efficiency Rating**

This graph shows the current efficiency of your home, taking into account both energy efficiency and fuel costs. The higher this rating, the lower your fuel bills are likely to be.

Your current rating is **band F (26)**. The average rating for EPCs in Scotland is **band D (61)**.

The potential rating shows the effect of undertaking all of the improvement measures listed within your recommendations report.

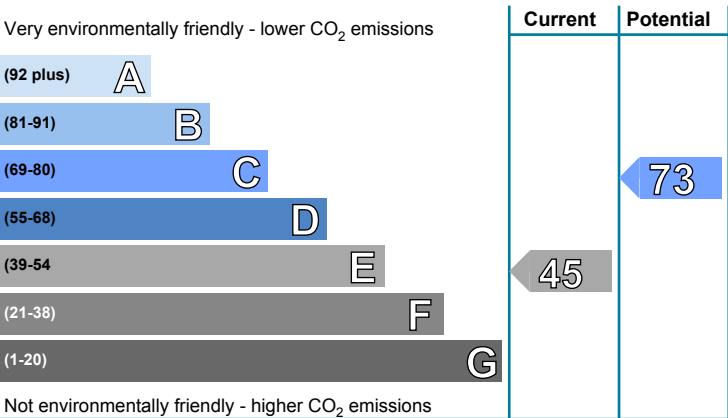
**Environmental Impact (CO<sub>2</sub>) Rating**

This graph shows the effect of your home on the environment in terms of carbon dioxide (CO<sub>2</sub>) emissions. The higher the rating, the less impact it has on the environment.
