Flat F,
159 Welbeck Crescent,
Troon,
Ayrshire,
KA10 6AP

Home Report

Single Survey

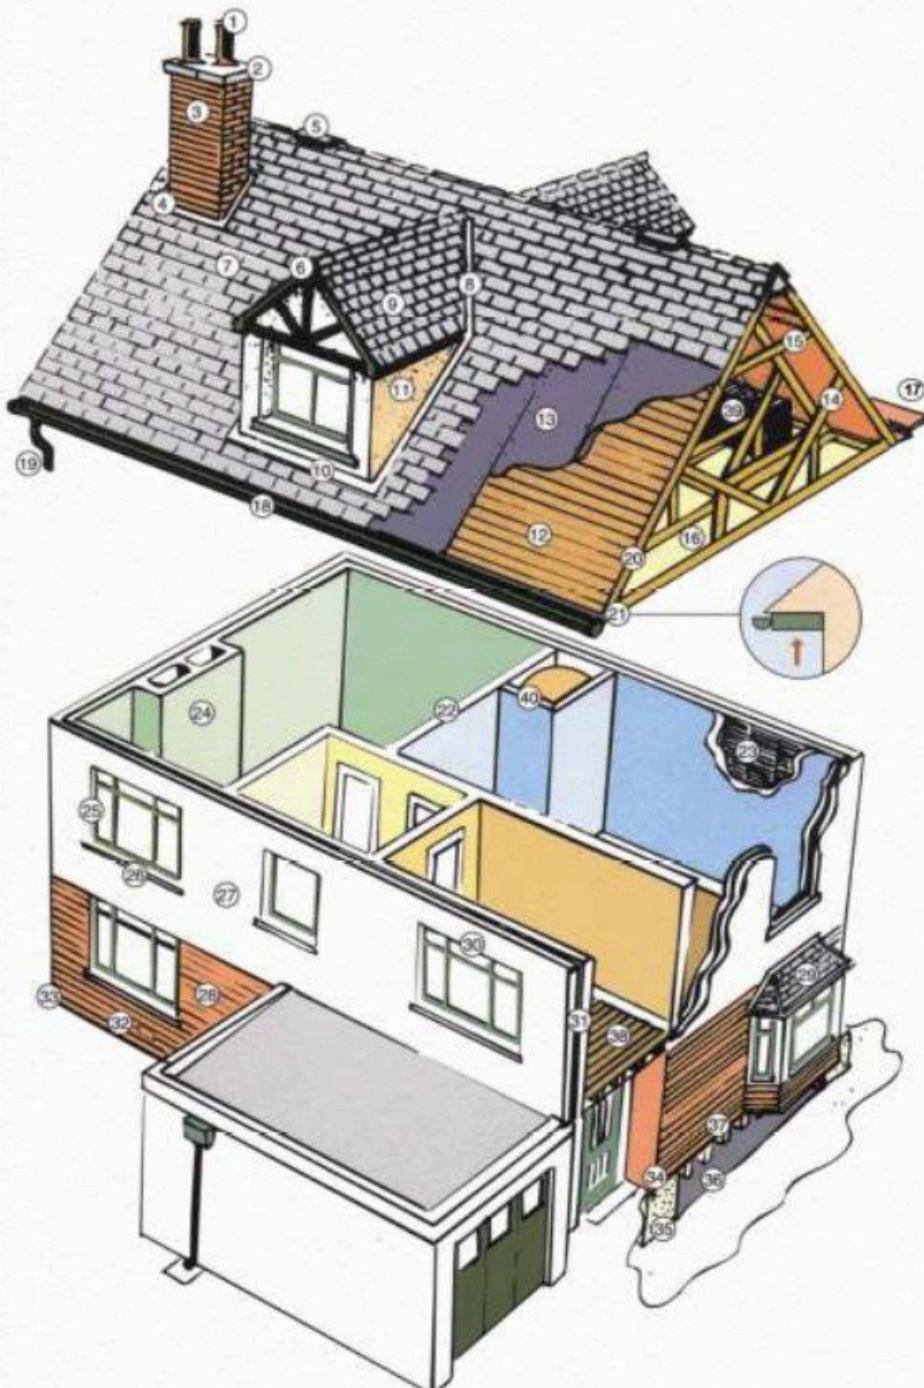
Sectional Diagram showing elements of a typical house

- 1 Chimney pots
- 2 Coping stone
- 3 Chimney head
- 4 Flashing
- 5 Ridge ventilation
- 6 Ridge board
- 7 Slates / tiles
- 8 Valley guttering
- 9 Dormer projection
- 10 Dormer flashing
- 11 Dormer cheeks
- 12 Sarking
- 13 Roof felt
- 14 Trusses
- 15 Collar
- 16 Insulation
- 17 Parapet gutter
- 18 Eaves guttering
- 19 Rainwater downpipe
- 20 Verge boards / skews
- 21 Soffit boards
- 22 Partition wall
- 23 Lath / plaster
- 24 Chimney breast
- 25 Window pointing
- 26 Window sills
- 27 Rendering
- 28 Brickwork / pointing
- 29 Bay window projection
- 30 Lintels
- 31 Cavity walls / wall ties
- 32 Subfloor ventilator
- 33 Damp proof course
- 34 Base course
- 35 Foundations
- 36 Solum
- 37 Floor joists
- 38 Floorboards
- 39 Water tank
- 40 Hot water tank

Reference may be made in this report to some or all of the above component parts of the property. This diagram may assist you in locating and understanding these items.
