# YOUR ONESURVEY HOME REPORT

Carslea  
Garmouth Road  
Lhanbryde, Elgin  
IV30 8PD

# SINGLE SURVEY

A report on the condition of the property, with categories being rated from 1 to 3.

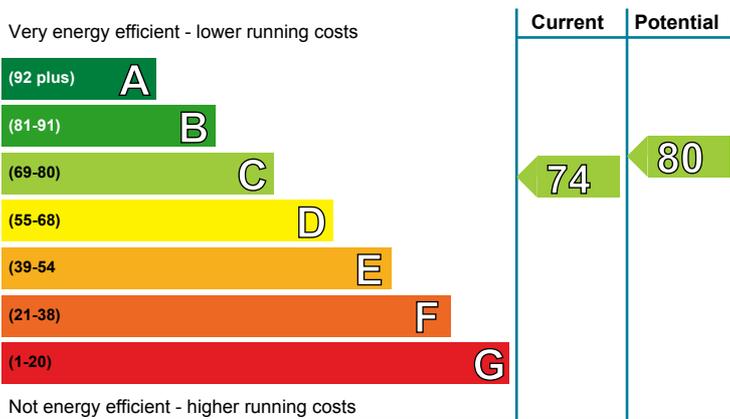
## Energy Efficiency Rating

This graph shows the current efficiency of your home, taking into account both energy efficiency and fuel costs. The higher this rating, the lower your fuel bills are likely to be.

Your current rating is **band C (74)**. The average rating for EPCs in Scotland is **band D (61)**.

The potential rating shows the effect of undertaking all of the improvement measures listed within your recommendations report.

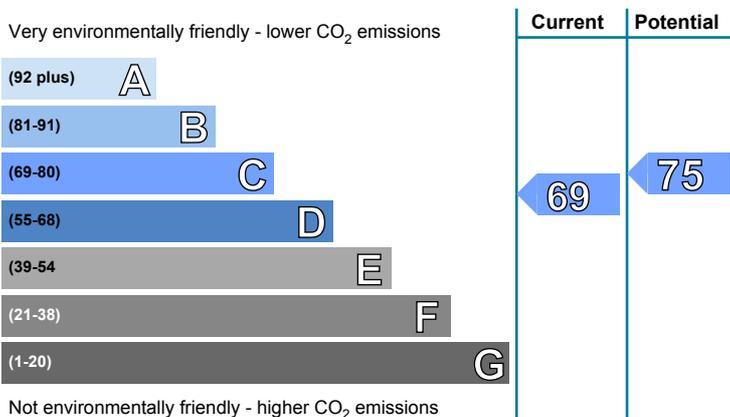
## Environmental Impact (CO<sub>2</sub>) Rating

This graph shows the effect of your home on the environment in terms of carbon dioxide (CO<sub>2</sub>) emissions. The higher the rating, the less impact it has on the environment.
