Home Report

Grianach
Windhill Beauly IV4 7AD

Single Survey

| Prepared by | Graham + Sibbald Property Consultants Limited |

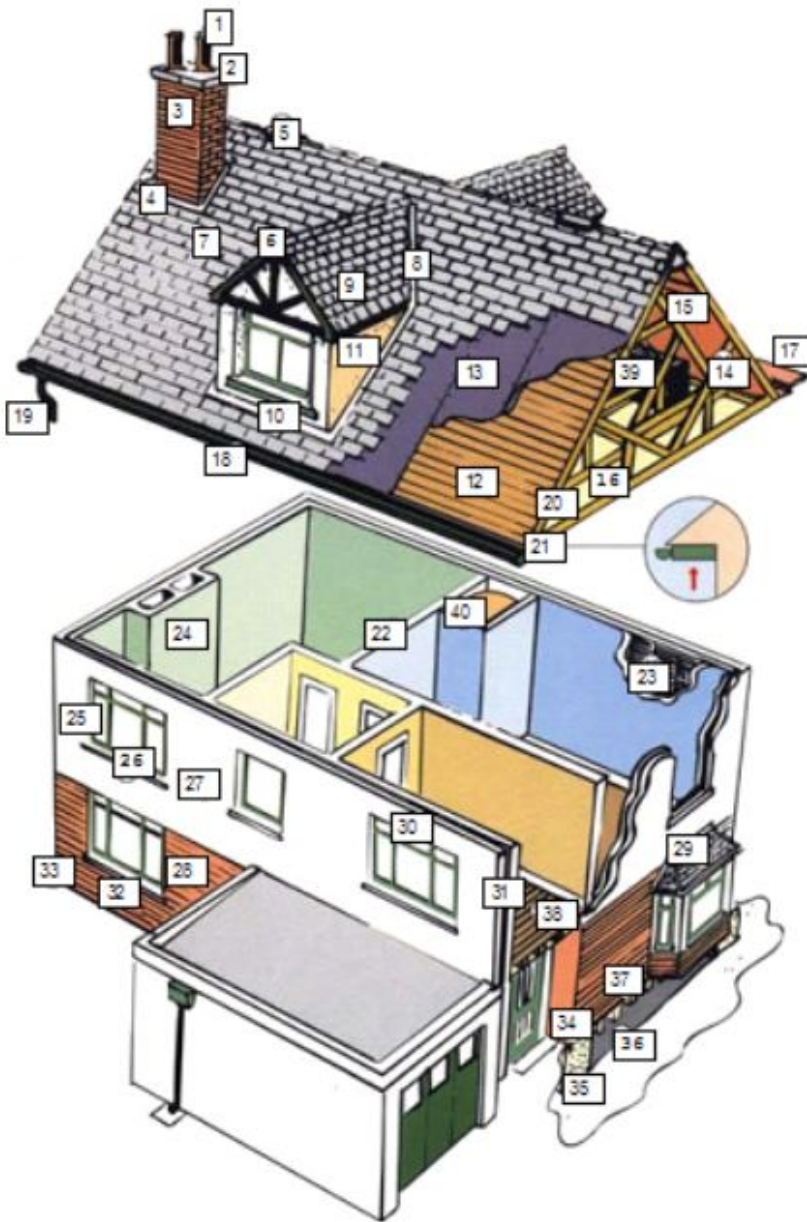
Sectional diagram showing elements of a typical house

| 1 | Chimney pots |
| 2 | Coping stone |
| 35 | Foundations |

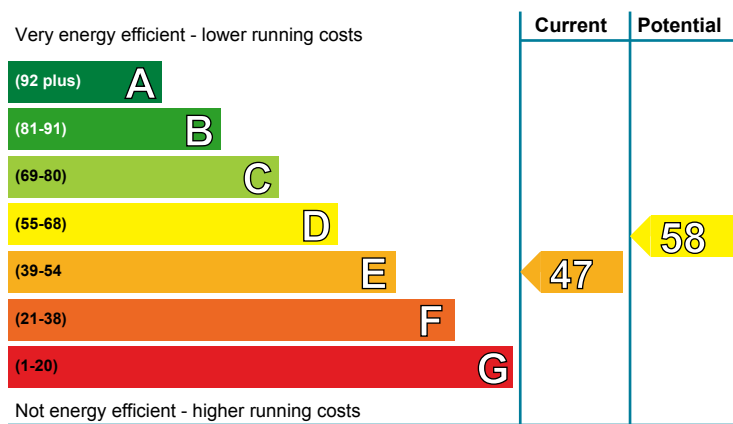
Energy Efficiency Rating

This graph shows the current efficiency of your home, taking into account both energy efficiency and fuel costs. The higher this rating, the lower your fuel bills are likely to be.

Your current rating is **band E (47)**. The average rating for EPCs in Scotland is **band D (61)**.

The potential rating shows the effect of undertaking all of the improvement measures listed within your recommendations report.

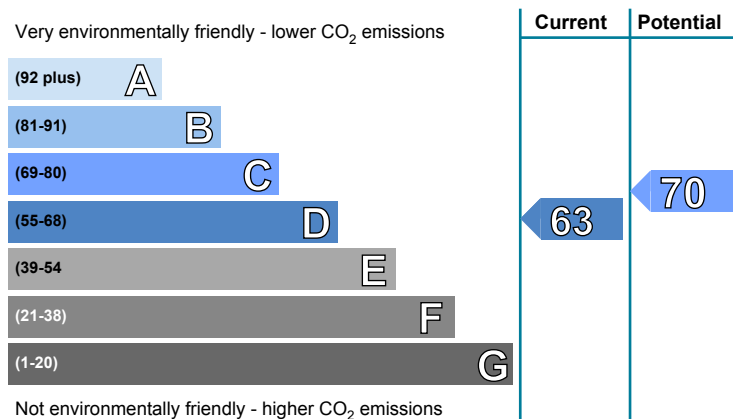
Environmental Impact (CO₂) Rating

This graph shows the effect of your home on the environment in terms of carbon dioxide (CO₂) emissions. The higher the rating, the less impact it has on the environment.
