# Home Report

Walmar Cottage  
Elliot Arbroath DD11 2PE

# Single Survey

| <b>Property Address</b> | Walmar Cottage<br><br>Elliot Arbroath<br>DD11 2PE |

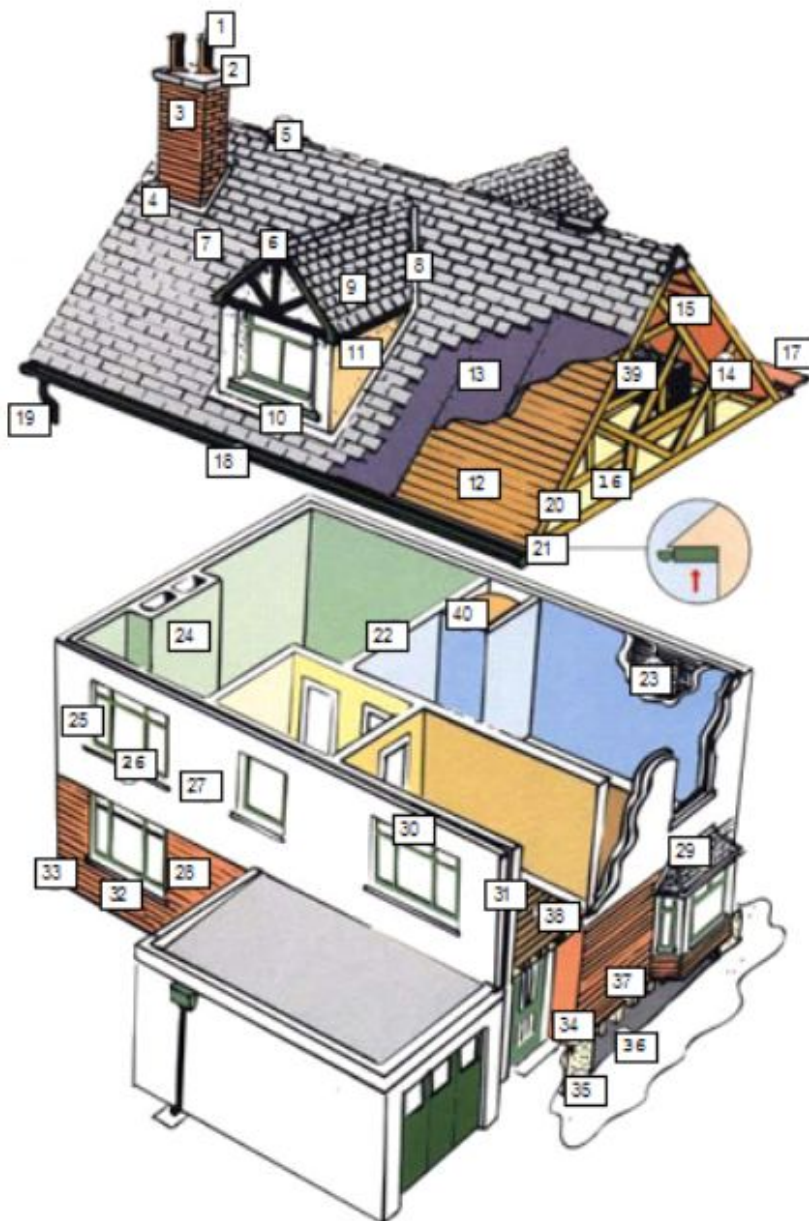
## Sectional diagram showing elements of a typical house

| 1 | Chimney pots |
| 2 | Coping stone |
| 35 | Foundations |

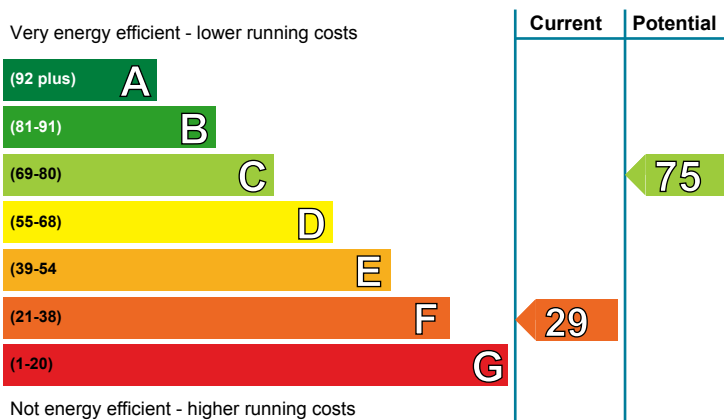
## Energy Efficiency Rating

Very energy efficient - lower running costs

This graph shows the current efficiency of your home, taking into account both energy efficiency and fuel costs. The higher this rating, the lower your fuel bills are likely to be.

The potential rating shows the effect of undertaking all of the improvement measures listed within your recommendations report.

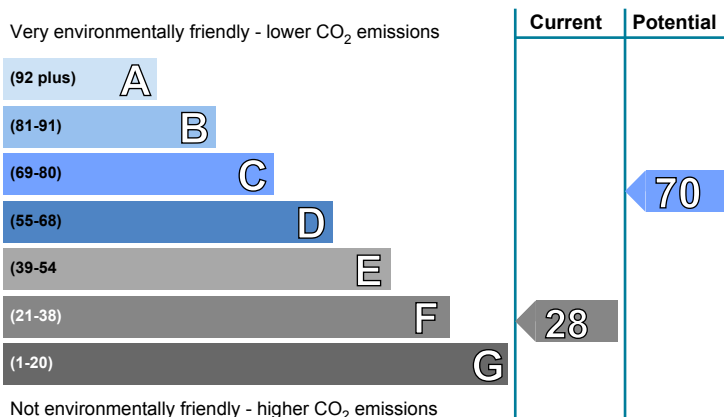
## Environmental Impact (CO<sub>2</sub>) Rating

Very environmentally friendly - lower CO<sub>2</sub> emissions

This graph shows the effect of your home on the environment in terms of carbon dioxide (CO<sub>2</sub>) emissions. The higher the rating, the less impact it has on the environment.
