# YOUR ONESURVEY HOME REPORT

12 Fountain Court  
Burghead, Elgin  
IV30 5PZ

# SINGLE SURVEY

A report on the condition of the property, with categories  
being rated from 1 to 3.

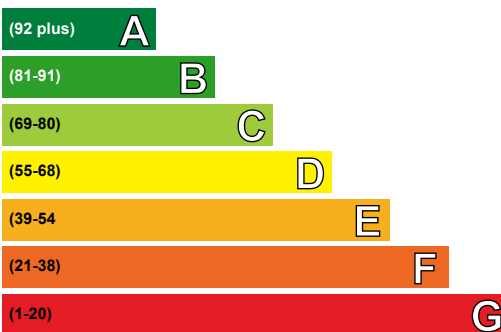
Very energy efficient - lower running costs

| Current | Potential |
| 71 | 71 |

Not energy efficient - higher running costs

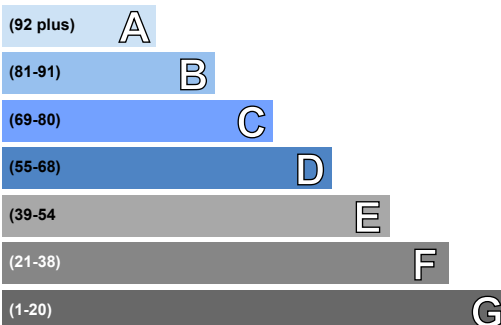
Very environmentally friendly - lower CO<sub>2</sub> emissions

| Current | Potential |
| 88 | 88 |
