YOUR ONESURVEY
HOME REPORT

Flat 3
16 Store Lane
Rothesay
Isle of Bute, PA20 9AA

SINGLE SURVEY

Single Survey

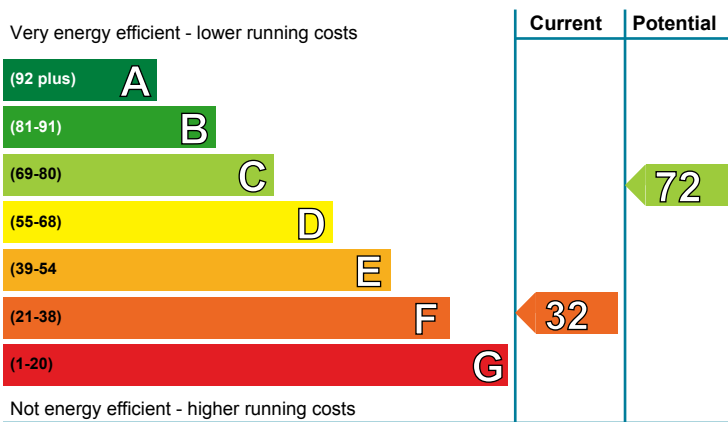
Energy Efficiency Rating

This graph shows the current efficiency of your home, taking into account both energy efficiency and fuel costs. The higher this rating, the lower your fuel bills are likely to be.

Your current rating is **band F (32)**. The average rating for EPCs in Scotland is **band D (61)**.

The potential rating shows the effect of undertaking all of the improvement measures listed within your recommendations report.

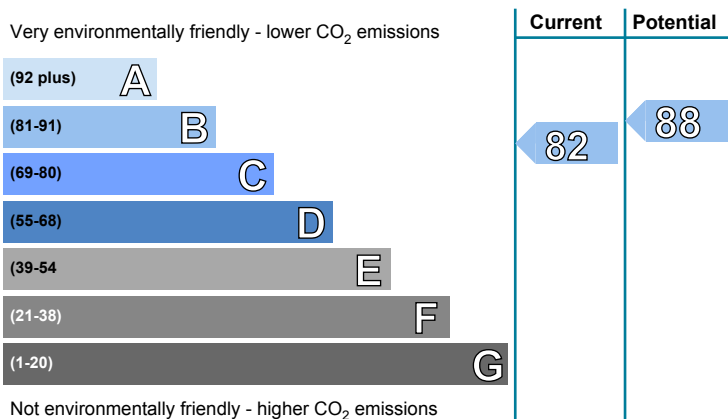
Environmental Impact (CO₂) Rating

This graph shows the effect of your home on the environment in terms of carbon dioxide (CO₂) emissions. The higher the rating, the less impact it has on the environment.
