Home Report

Scottish Single Survey

Single Survey

Property address	9 Fingleton Avenue Barrhead Glasgow G78 2HQ
Customer	[REDACTED]
Customer address	9 Fingleton Avenue Barrhead Glasgow G78 2HQ
Prepared by	Shepherd Chartered Surveyors
Date of inspection	17/06/2026

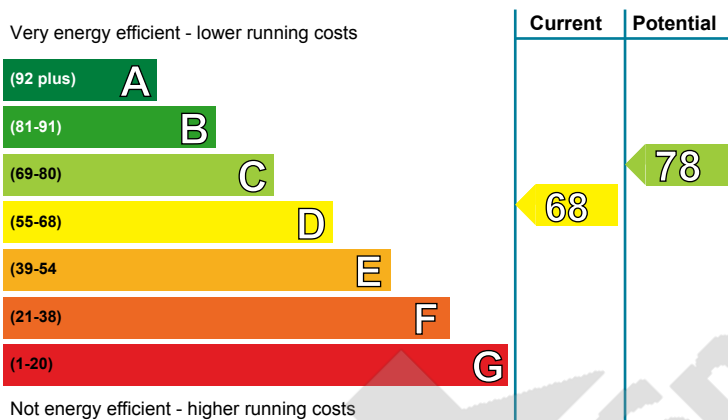
Energy Efficiency Rating

This graph shows the current efficiency of your home, taking into account both energy efficiency and fuel costs. The higher this rating, the lower your fuel bills are likely to be.

Your current rating is **band D (68)**. The average rating for EPCs in Scotland is **band D (61)**.

The potential rating shows the effect of undertaking all of the improvement measures listed within your recommendations report.

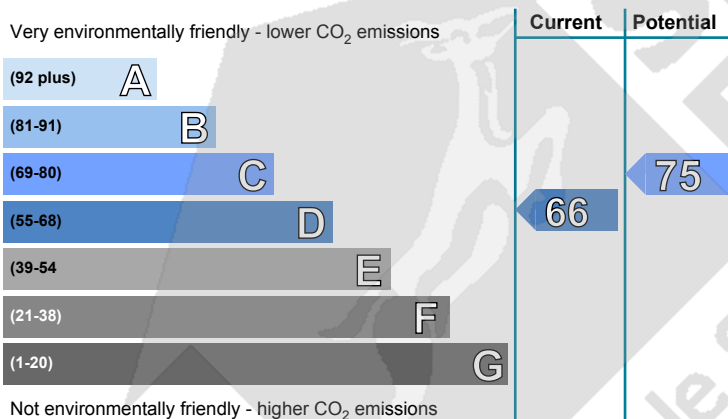
Environmental Impact (CO₂) Rating

This graph shows the effect of your home on the environment in terms of carbon dioxide (CO₂) emissions. The higher the rating, the less impact it has on the environment.
