YOUR ONESURVEY
HOME REPORT

Janefield Cottage
49 Otago Street
Hillhead
Glasgow, G12 8PQ

SINGLE SURVEY

Single Survey

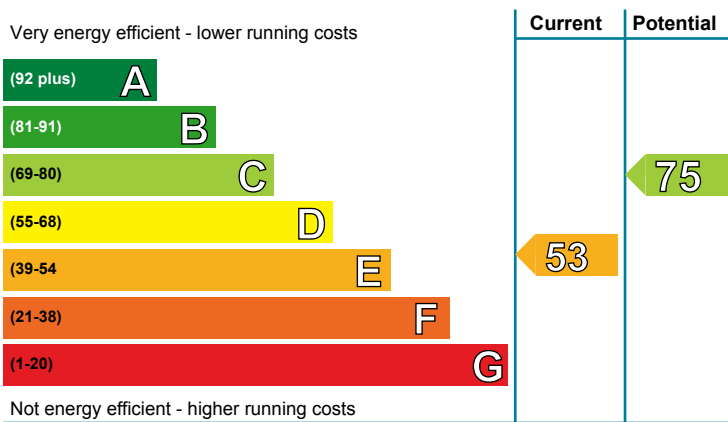
Energy Efficiency Rating

This graph shows the current efficiency of your home, taking into account both energy efficiency and fuel costs. The higher this rating, the lower your fuel bills are likely to be.

Your current rating is **band E (53)**. The average rating for EPCs in Scotland is **band D (61)**.

The potential rating shows the effect of undertaking all of the improvement measures listed within your recommendations report.

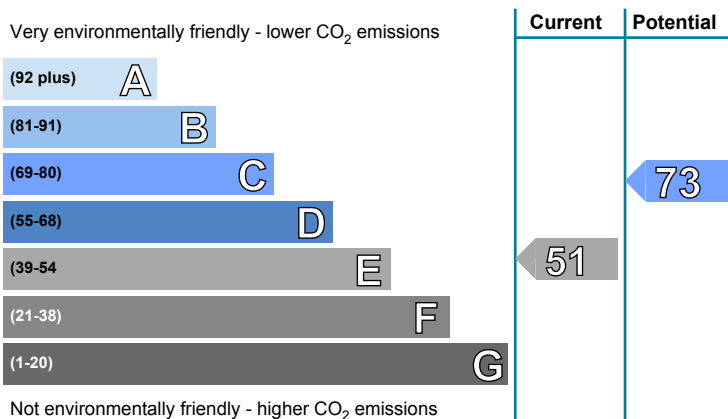
Environmental Impact (CO₂) Rating

This graph shows the effect of your home on the environment in terms of carbon dioxide (CO₂) emissions. The higher the rating, the less impact it has on the environment.
