**HOME**  
report

# Single Survey

<b>Property Address</b>	Greenlea Drumnadrochit Inverness IV63 6TX
<b>Customer</b>	Mr G Findlay & Ms M Service
<b>Date of Inspection</b>	18/02/2026
<b>Prepared by</b>	Donna Shields Harvey Donaldson & Gibson Chartered Surveyors

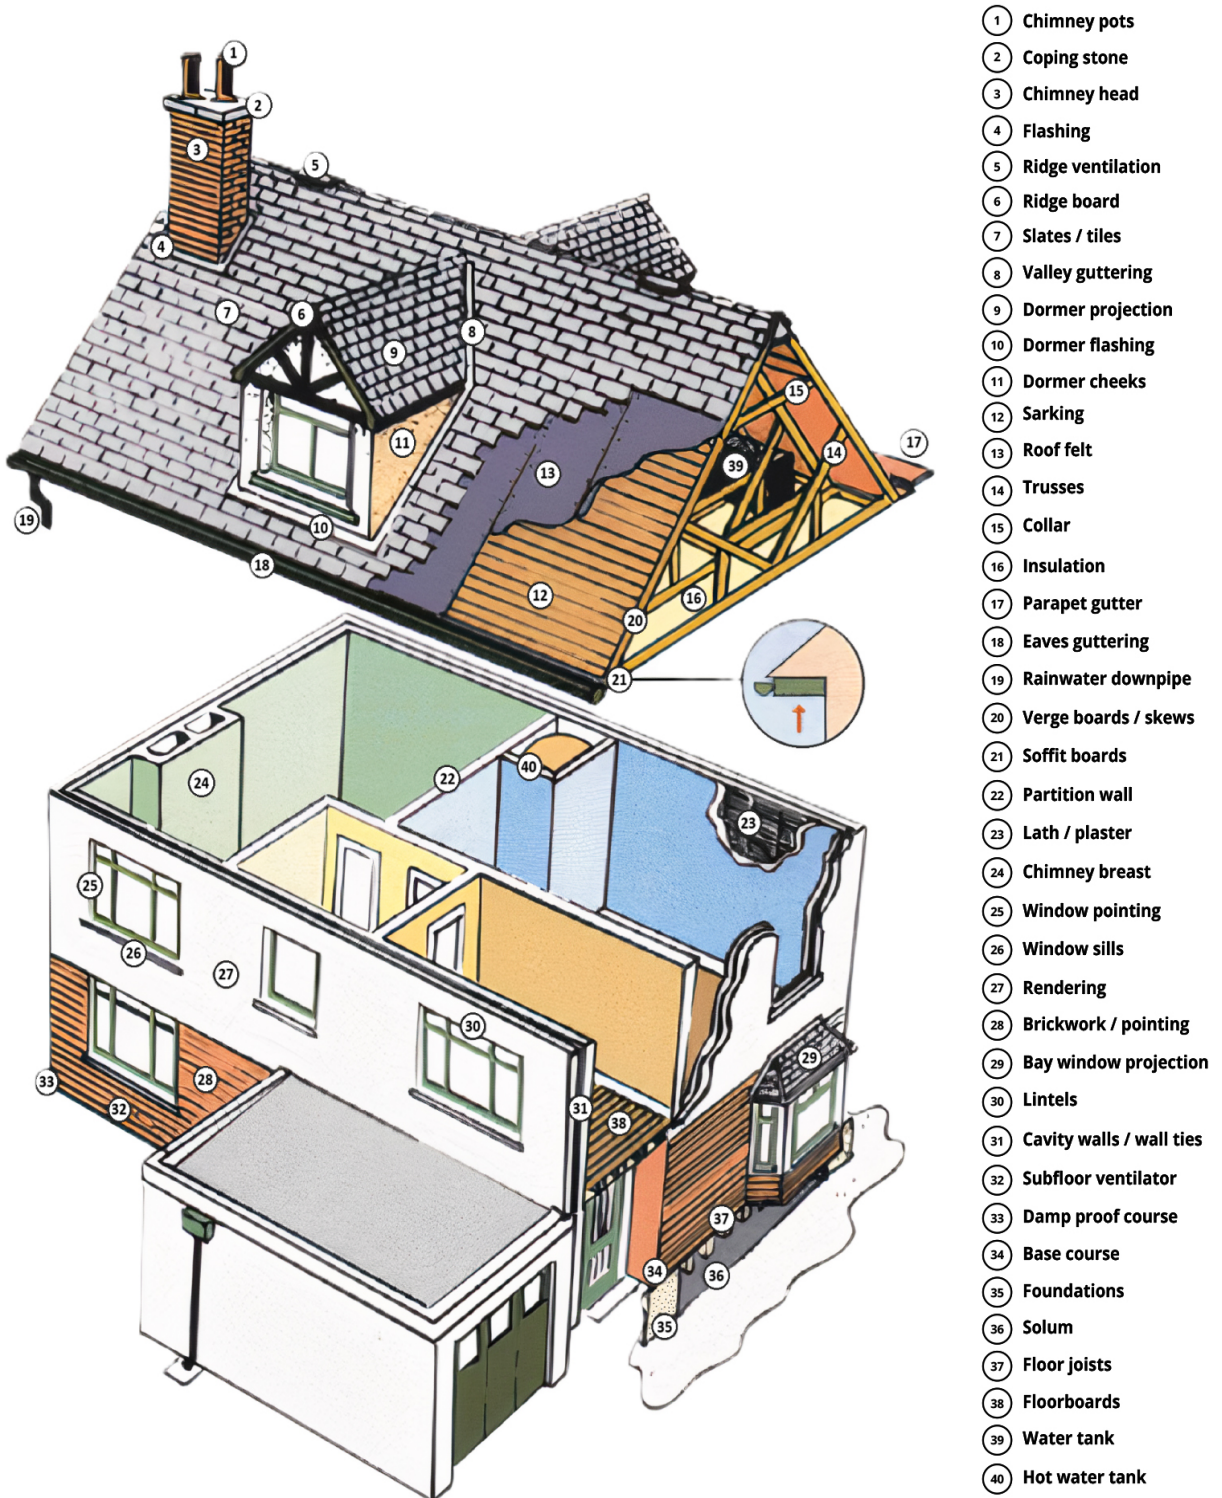
## Sectional Diagram showing elements of a typical house

Reference may be made in this report to some or all of the above component parts of the property. This diagram may assist you in locating and understanding these items.

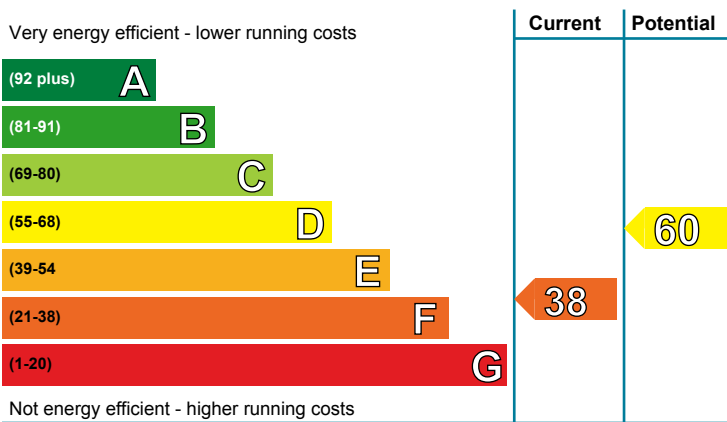
## Energy Efficiency Rating

This graph shows the current efficiency of your home, taking into account both energy efficiency and fuel costs. The higher this rating, the lower your fuel bills are likely to be.

Your current rating is **band F (38)**. The average rating for EPCs in Scotland is **band D (61)**.

The potential rating shows the effect of undertaking all of the improvement measures listed within your recommendations report.

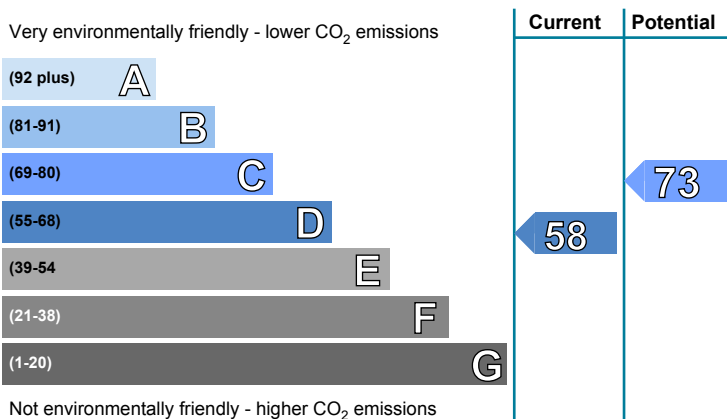
## Environmental Impact (CO<sub>2</sub>) Rating

This graph shows the effect of your home on the environment in terms of carbon dioxide (CO<sub>2</sub>) emissions. The higher the rating, the less impact it has on the environment.
