Home Report

Single Survey

Property address	20 Canonbie Avenue East Kilbride Glasgow G74 4GH
Customer	Lynsey Clark
Customer address	20 Canonbie Avenue East Kilbride Glasgow G74 4GH
Prepared by	Shepherd Chartered Surveyors
Date of inspection	16/02/2026

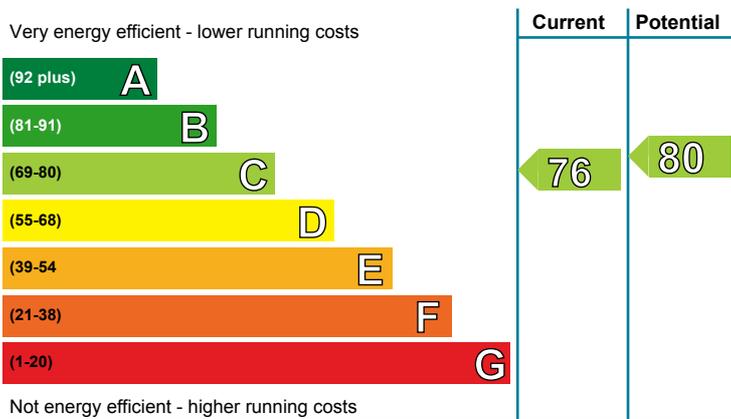
Energy Efficiency Rating

This graph shows the current efficiency of your home, taking into account both energy efficiency and fuel costs. The higher this rating, the lower your fuel bills are likely to be.

Your current rating is **band C (76)**. The average rating for EPCs in Scotland is **band D (61)**.

The potential rating shows the effect of undertaking all of the improvement measures listed within your recommendations report.

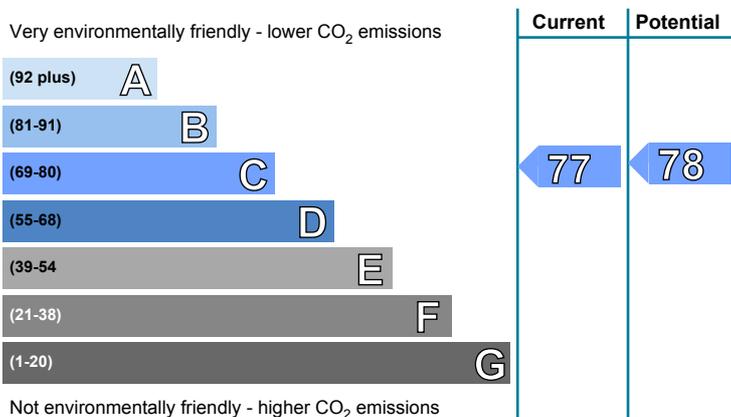
Environmental Impact (CO₂) Rating

This graph shows the effect of your home on the environment in terms of carbon dioxide (CO₂) emissions. The higher the rating, the less impact it has on the environment.
