# Home Report

18 Stormyhill Road,  
Portree,  
IV51 9DT

# Single Survey

## Survey Report on:

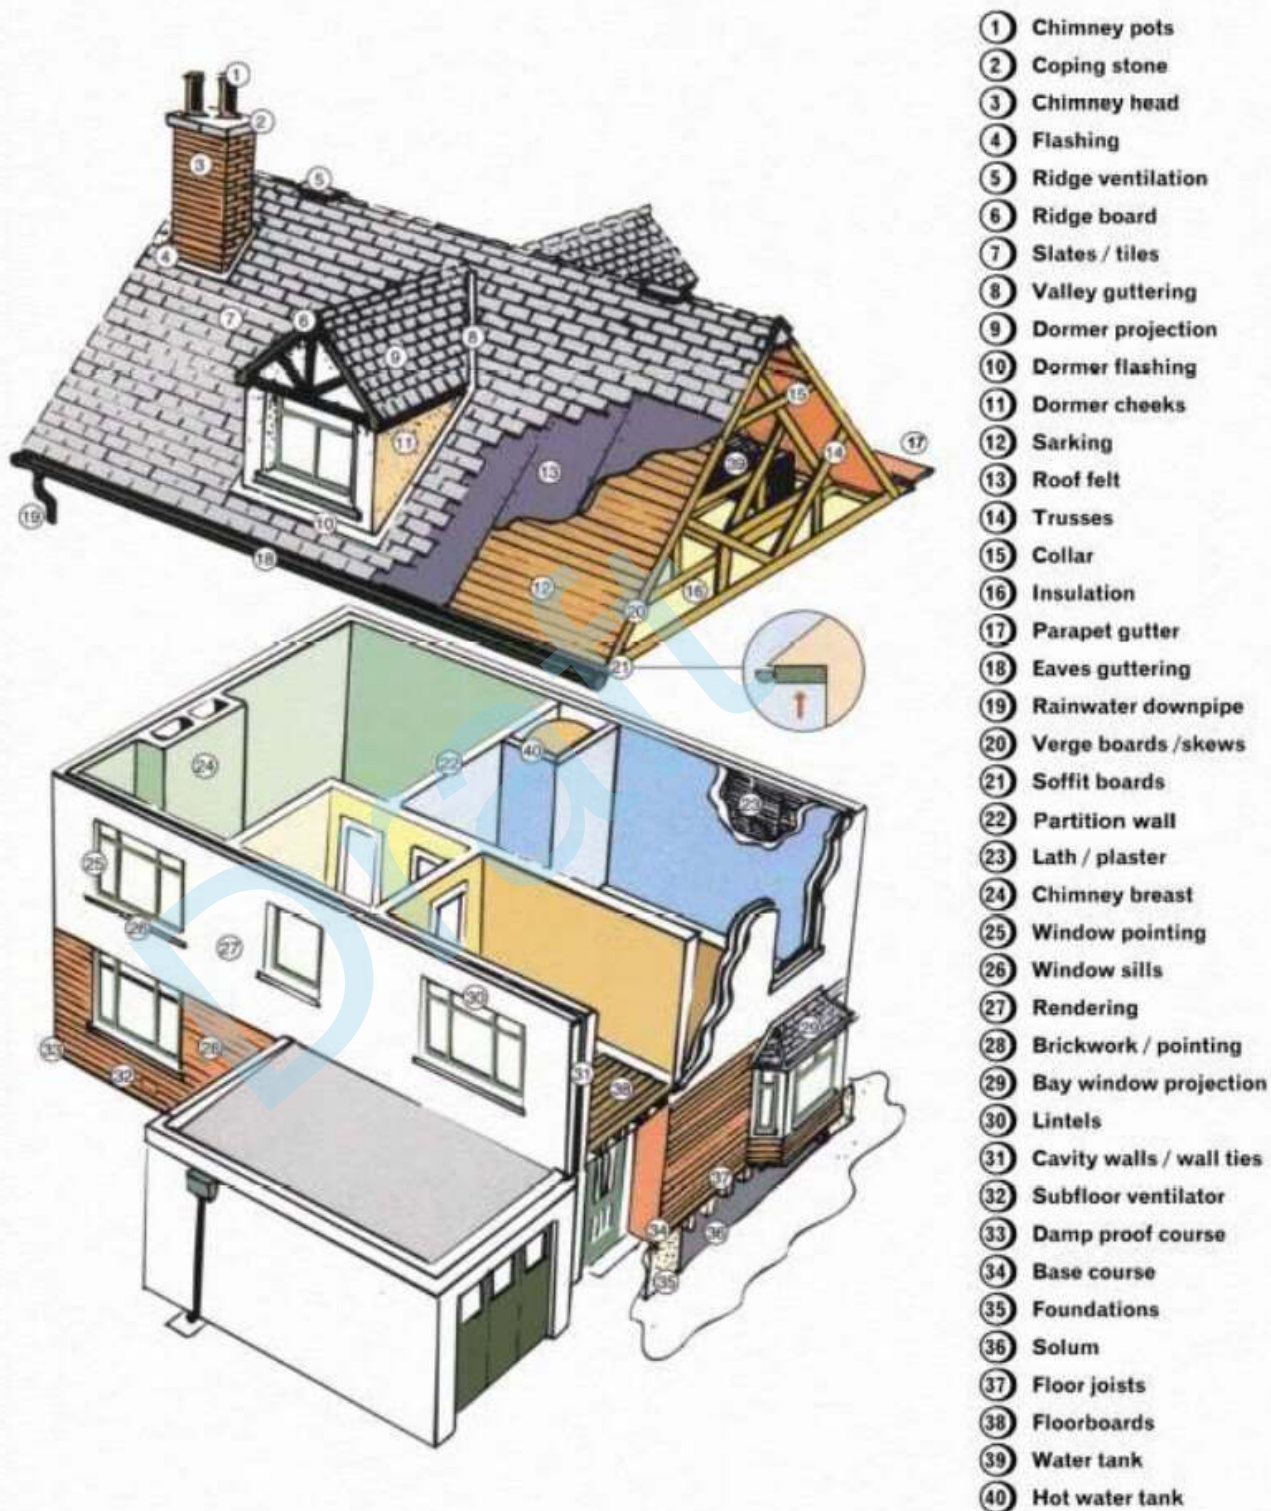
## Sectional Diagram showing elements of a typical house

Reference may be made in this report to some or all of the above component parts of the property. This diagram may assist you in locating and understanding these items.
