# YOUR ONESURVEY HOME REPORT

37 Western Road  
Kilmarnock  
KA3 1NQ

# SINGLE SURVEY

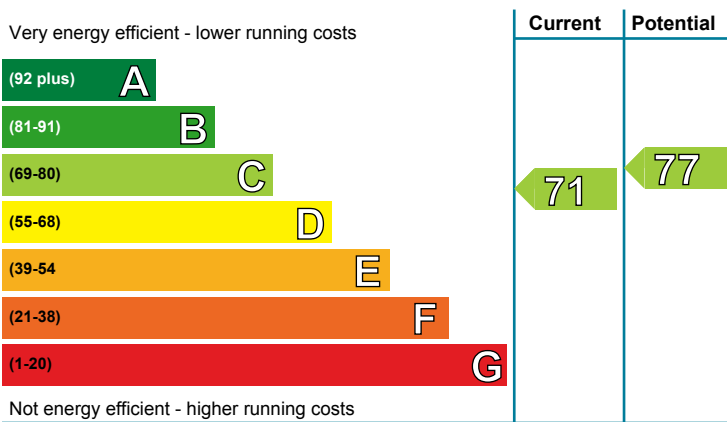
## Energy Efficiency Rating

This graph shows the current efficiency of your home, taking into account both energy efficiency and fuel costs. The higher this rating, the lower your fuel bills are likely to be.

Your current rating is **band C (71)**. The average rating for EPCs in Scotland is **band D (61)**.

The potential rating shows the effect of undertaking all of the improvement measures listed within your recommendations report.
