HOME REPORT

20B BENNISON SQUARE
EYEMOUTH
TD14 5SB

DM HALL
CHARTERED SURVEYORS

20B, BENNISON SQUARE, EYEMOUTH, TD14 5SB

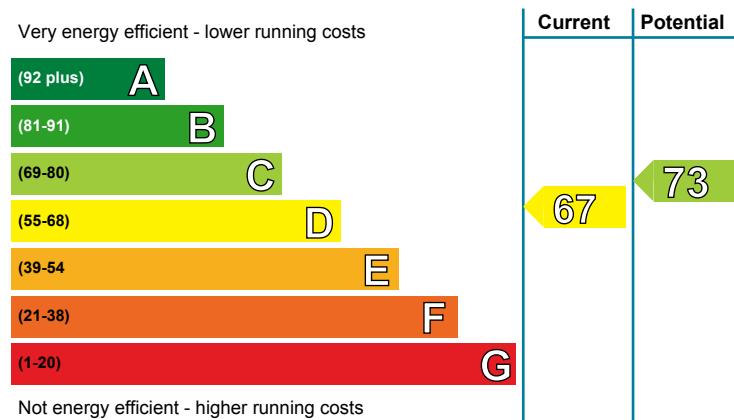
Energy Efficiency Rating

This graph shows the current efficiency of your home, taking into account both energy efficiency and fuel costs. The higher this rating, the lower your fuel bills are likely to be.

Your current rating is **band D (67)**. The average rating for EPCs in Scotland is **band D (61)**.

The potential rating shows the effect of undertaking all of the improvement measures listed within your recommendations report.

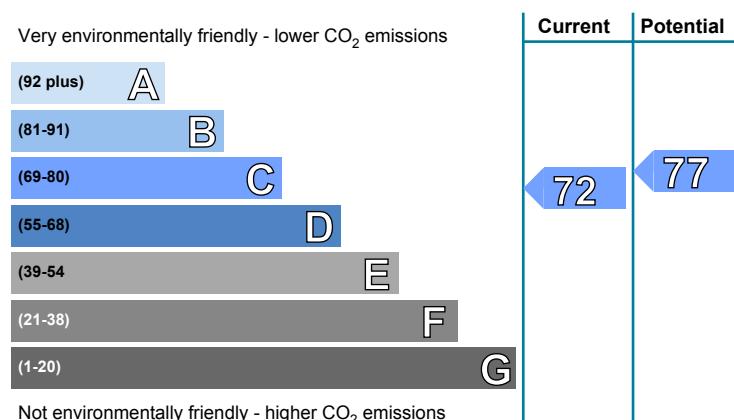
Environmental Impact (CO₂) Rating

This graph shows the effect of your home on the environment in terms of carbon dioxide (CO₂) emissions. The higher the rating, the less impact it has on the environment.

Your current rating is **band C (72)**

The potential rating shows the effect of undertaking all of the improvement measures listed within your recommendations report.
