Home Report

The Stables Kirkstyle
St. Vigeans Arbroath DD11 4RB

Single Survey

Property Address	The Stables Kirkstyle Arbroath DD11 4RB
Customer	Gail Edginton
Prepared by	Graham + Sibbald Property Consultants Limited
Date of Inspection	26/08/2025

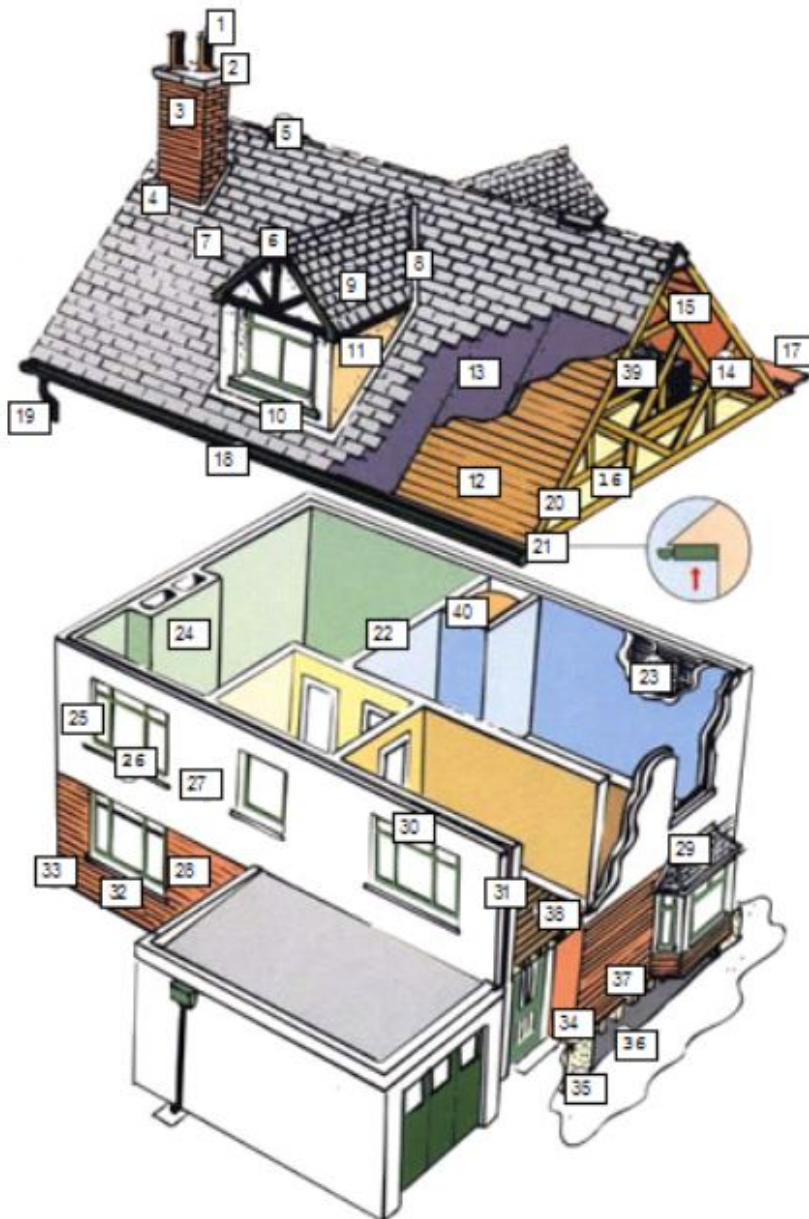
Sectional diagram showing elements of a typical house

1	Chimney pots
2	Coping stone
3	Chimney head
4	Flashing
5	Ridge ventilation
6	Ridge board
7	Slates / tiles
8	Valley guttering
9	Dormer projection
10	Dormer flashing
11	Dormer cheeks
12	Sarking
13	Roof felt
14	Trusses
15	Collar
16	Insulation
17	Parapet gutter
18	Eaves guttering
19	Rainwater downpipe
20	Verge boards / skewes
21	Soffit boards
22	Partition wall
23	Lath / plaster
24	Chimney breast
25	Window pointing
26	Window sills
27	Rendering
28	Brickwork / pointing
29	Bay window projection
30	Lintels
31	Cavity walls / wall ties
32	Subfloor ventilator
33	Damp proof course
34	Base course
35	Foundations
36	Solum
37	Floor joists
38	Floorboards
39	Water tank
40	Hot water tank

Reference may be made in this report to some or all of the above component parts of the property. This diagram may assist you in locating and understanding these items.

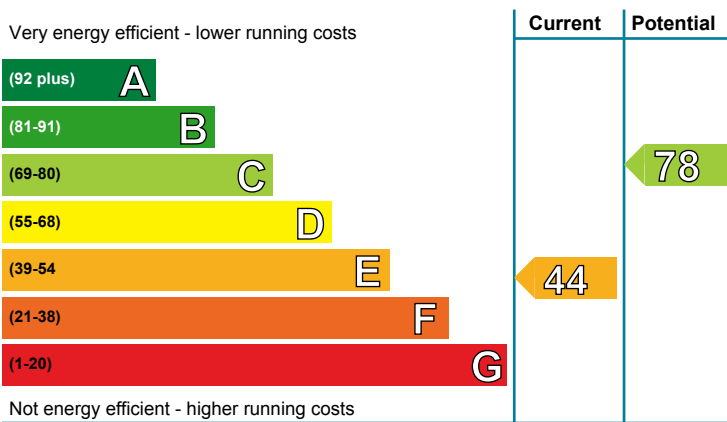
Energy Efficiency Rating

This graph shows the current efficiency of your home, taking into account both energy efficiency and fuel costs. The higher this rating, the lower your fuel bills are likely to be.

Your current rating is **band E (44)**. The average rating for EPCs in Scotland is **band D (61)**.

The potential rating shows the effect of undertaking all of the improvement measures listed within your recommendations report.

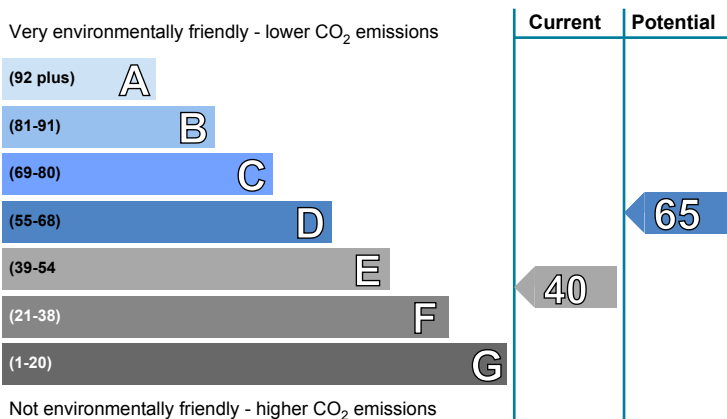
Environmental Impact (CO₂) Rating

This graph shows the effect of your home on the environment in terms of carbon dioxide (CO₂) emissions. The higher the rating, the less impact it has on the environment.
