YOUR ONESURVEY  
**HOME REPORT**

Flat 12  
2 West Chapelton Avenue  
Bearsden  
Glasgow, G61 2DQ

# SINGLE SURVEY

A report on the condition of the property, with categories being rated from 1 to 3.

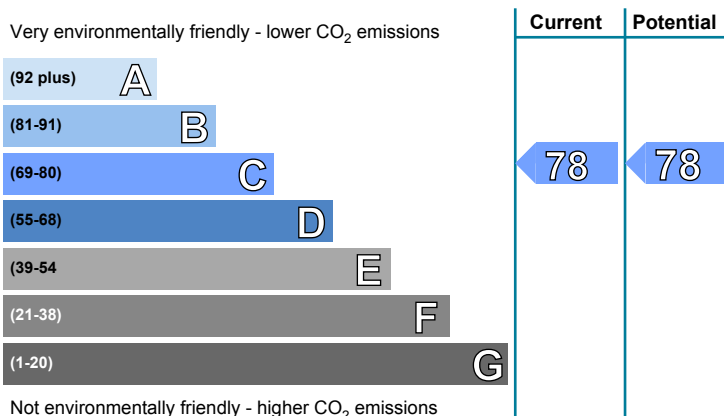
## Environmental Impact (CO<sub>2</sub>) Rating

This graph shows the effect of your home on the environment in terms of carbon dioxide (CO<sub>2</sub>) emissions. The higher the rating, the less impact it has on the environment.
