Home Report

Single Survey

Property address	45 Rosevale Road Dumfries DG1 4HX
Customer	[REDACTED]
Customer address	45 Rosevale Road Dumfries DG1 4HX
Prepared by	Shepherd Chartered Surveyors
Date of inspection	03/02/2026

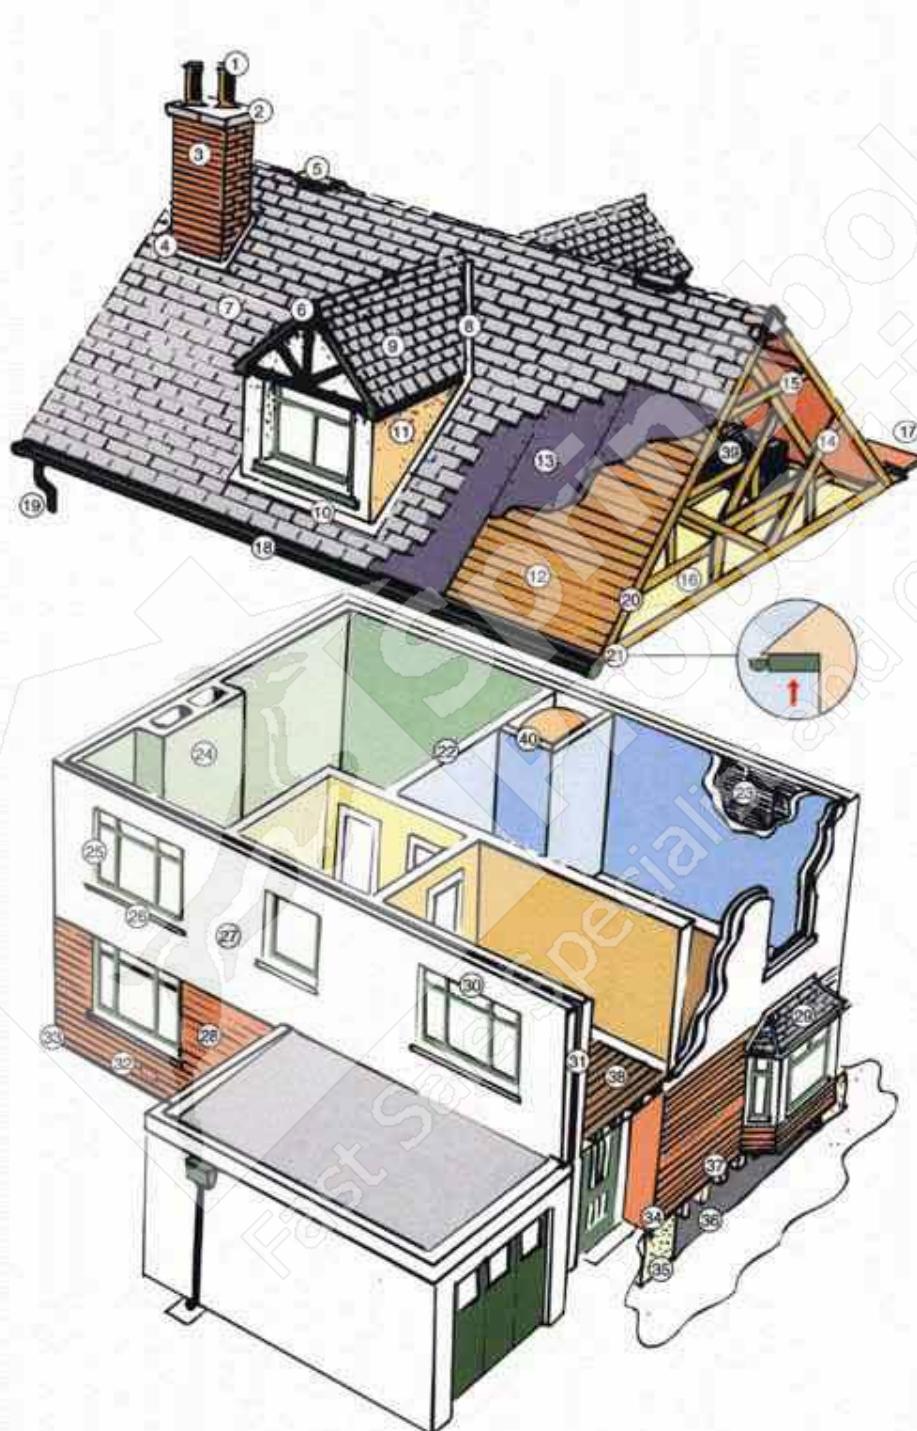
Sectional Diagram showing elements of a typical house

- 1 Chimney pots
- 2 Coping stone
- 3 Chimney head
- 4 Flashing
- 5 Ridge ventilation
- 6 Ridge board
- 7 Slates / tiles
- 8 Valley guttering
- 9 Dormer projection
- 10 Dormer flashing
- 11 Dormer cheeks
- 12 Sarking
- 13 Roof felt
- 14 Trusses
- 15 Collar
- 16 Insulation
- 17 Parapet gutter
- 18 Eaves guttering
- 19 Rainwater downpipe
- 20 Verge boards /skews
- 21 Soffit boards
- 22 Partition wall
- 23 Lath / plaster
- 24 Chimney breast
- 25 Window pointing
- 26 Window sills
- 27 Rendering
- 28 Brickwork / pointing
- 29 Bay window projection
- 30 Lintels
- 31 Cavity walls / wall ties
- 32 Subfloor ventilator
- 33 Damp proof course
- 34 Base course
- 35 Foundations
- 36 Solum
- 37 Floor joists
- 38 Floorboards
- 39 Water tank
- 40 Hot water tank

Reference may be made in this report to some or all of the above component parts of the property. This diagram may assist you in locating and understanding these items.

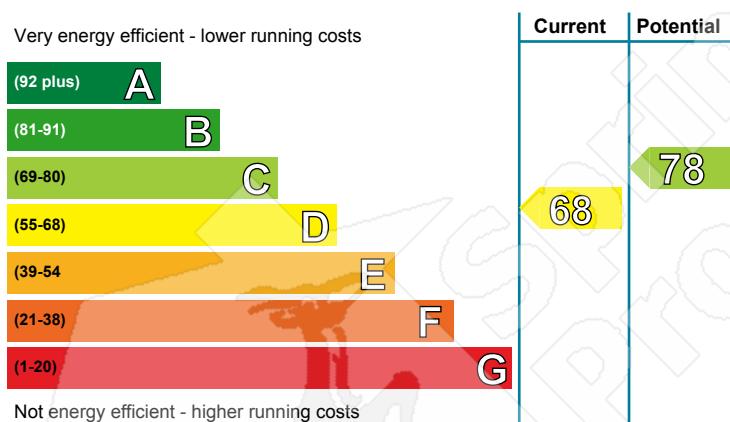
Energy Efficiency Rating

This graph shows the current efficiency of your home, taking into account both energy efficiency and fuel costs. The higher this rating, the lower your fuel bills are likely to be.

Your current rating is **band D (68)**. The average rating for EPCs in Scotland is **band D (61)**.

The potential rating shows the effect of undertaking all of the improvement measures listed within your recommendations report.

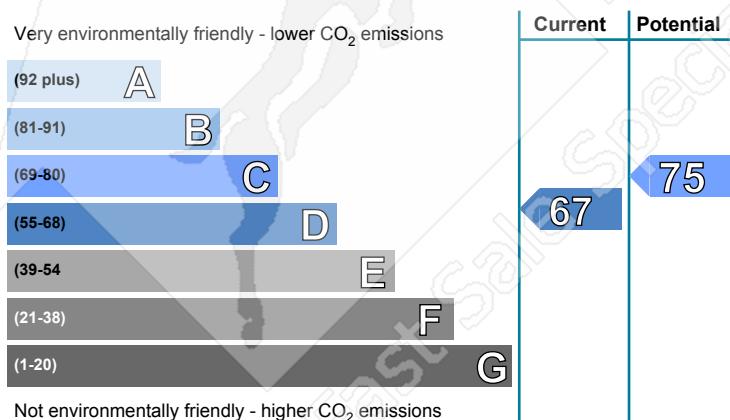
Environmental Impact (CO₂) Rating

This graph shows the effect of your home on the environment in terms of carbon dioxide (CO₂) emissions. The higher the rating, the less impact it has on the environment.
