YOUR ONESURVEY  
**HOME REPORT**

The Old Shop  
Belhelvie Village  
Balmedie  
AB23 8YU

# SINGLE SURVEY

A report on the condition of the property, with categories being rated from 1 to 3.

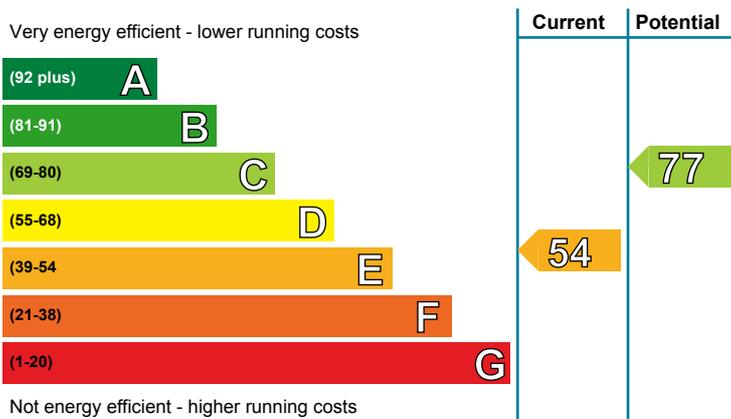
## Energy Efficiency Rating

This graph shows the current efficiency of your home, taking into account both energy efficiency and fuel costs. The higher this rating, the lower your fuel bills are likely to be.

Your current rating is **band E (54)**. The average rating for EPCs in Scotland is **band D (61)**.

The potential rating shows the effect of undertaking all of the improvement measures listed within your recommendations report.

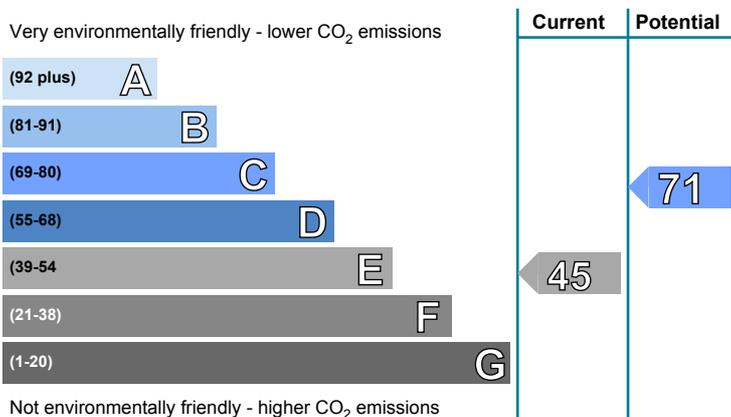
## Environmental Impact (CO<sub>2</sub>) Rating

This graph shows the effect of your home on the environment in terms of carbon dioxide (CO<sub>2</sub>) emissions. The higher the rating, the less impact it has on the environment.
