Flat 1,
The Auld Mill,
Station Road,
TURRIFF,
AB53 4ER

Home Report

Single Survey

Survey Report on:

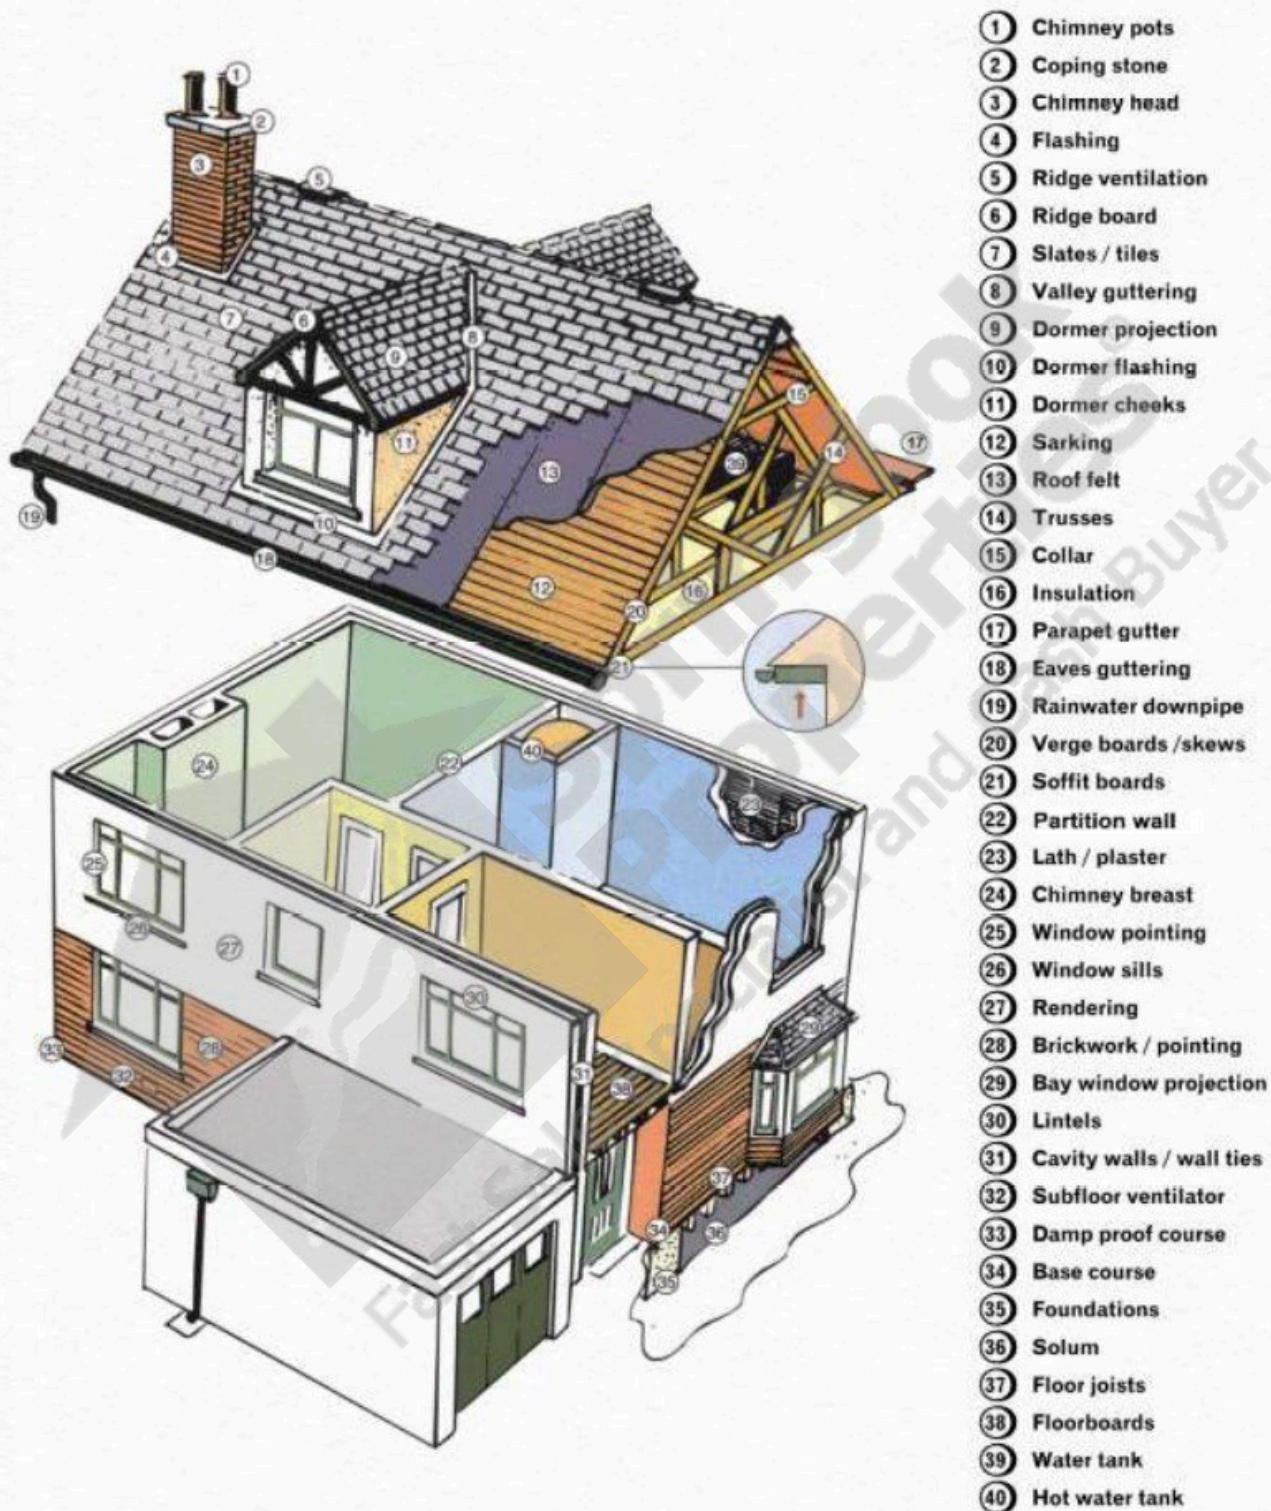
Sectional Diagram showing elements of a typical house

Reference may be made in this report to some or all of the above component parts of the property. This diagram may assist you in locating and understanding these items.
