# Home Report

# Scottish Single Survey

<b>Property address</b>	1/1 16 Lesmuir Place Glasgow G14 0EJ
-------------------------	---

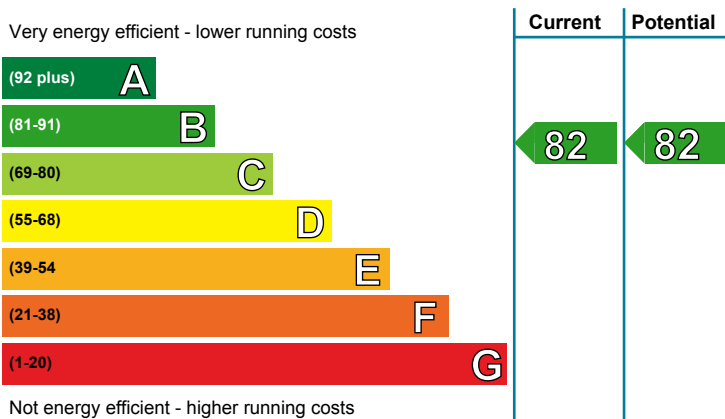
## Energy Efficiency Rating

This graph shows the current efficiency of your home, taking into account both energy efficiency and fuel costs. The higher this rating, the lower your fuel bills are likely to be.

Your current rating is **band B (82)**. The average rating for EPCs in Scotland is **band D (61)**.

The potential rating shows the effect of undertaking all of the improvement measures listed within your recommendations report.
